BY THE COMPTROLLER GENERAL
**Report To The Honorable
G. William Whitehurst
U. S. House Of Representatives**
OF THE UNITED STATES

Navy Has Housing Problems At Virginia Beach And Scrap Metal Disposal Problems At Sewells Point

PSAD-80-73
SEPTEMBER 19, 1980

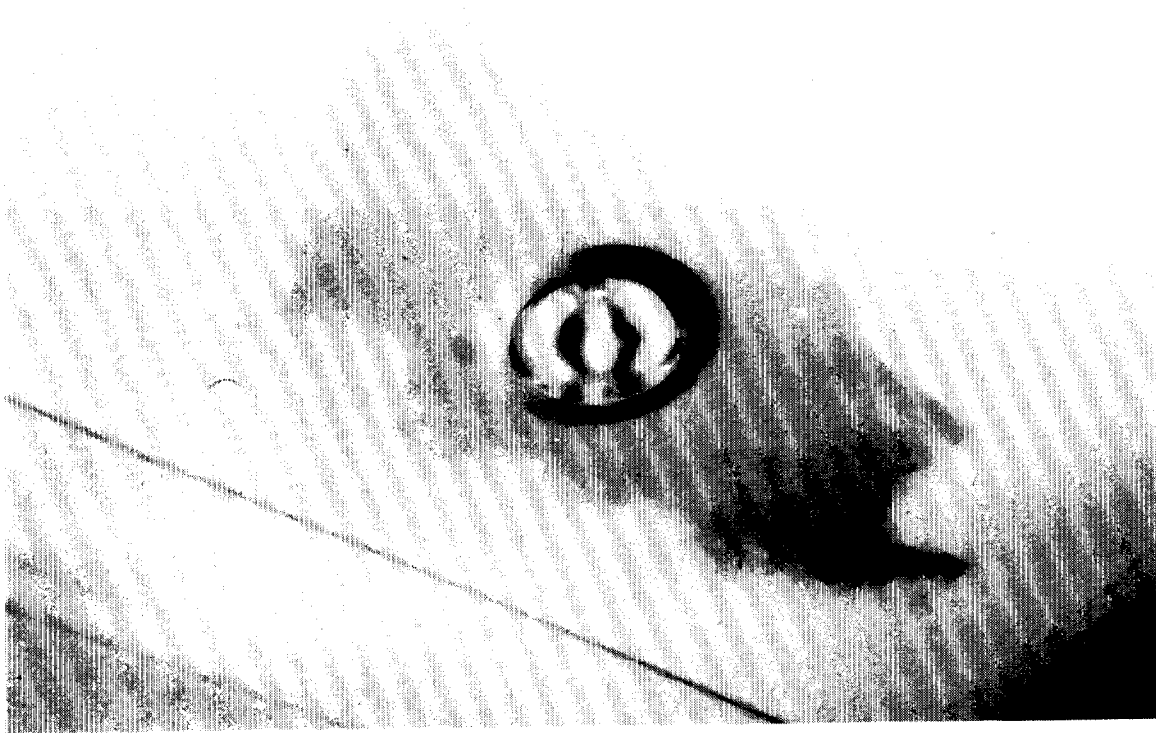
1135 GEORGIA

**CEILING DAMAGE AROUND LIGHT OVER KITCHEN SINK CAUSED BY WATER
LEAKING FROM LOOSE ESCUTCHEONS IN THE UPSTAIRS BATHROOM.**

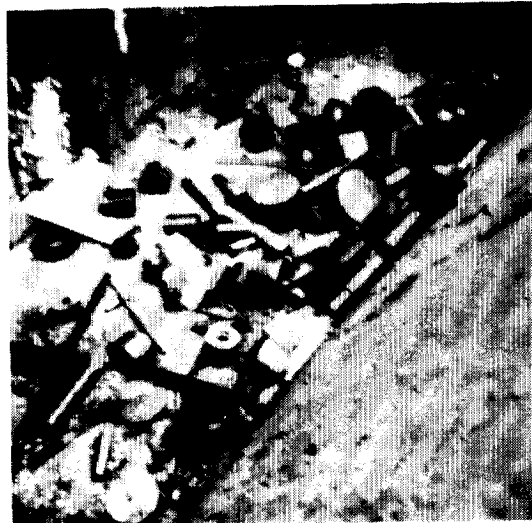
PIER 24, 12/13/79

HEAVY STEEL, HEAVY GEARS/SOC-
KETS OF VARIOUS SIZES, ESTIMATED
VALUE \$75 A TON

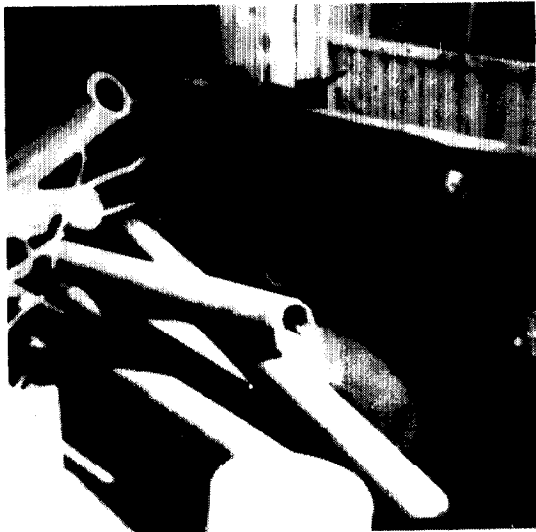
Z-93, 12/5/79
STEEL PIPE, LIGHT AND HEAVY,
ESTIMATED AT \$40 A TON
