GAO

# QUALITY ASSURANCE

## Concerns About Four Navy Missile Systems

B-225066

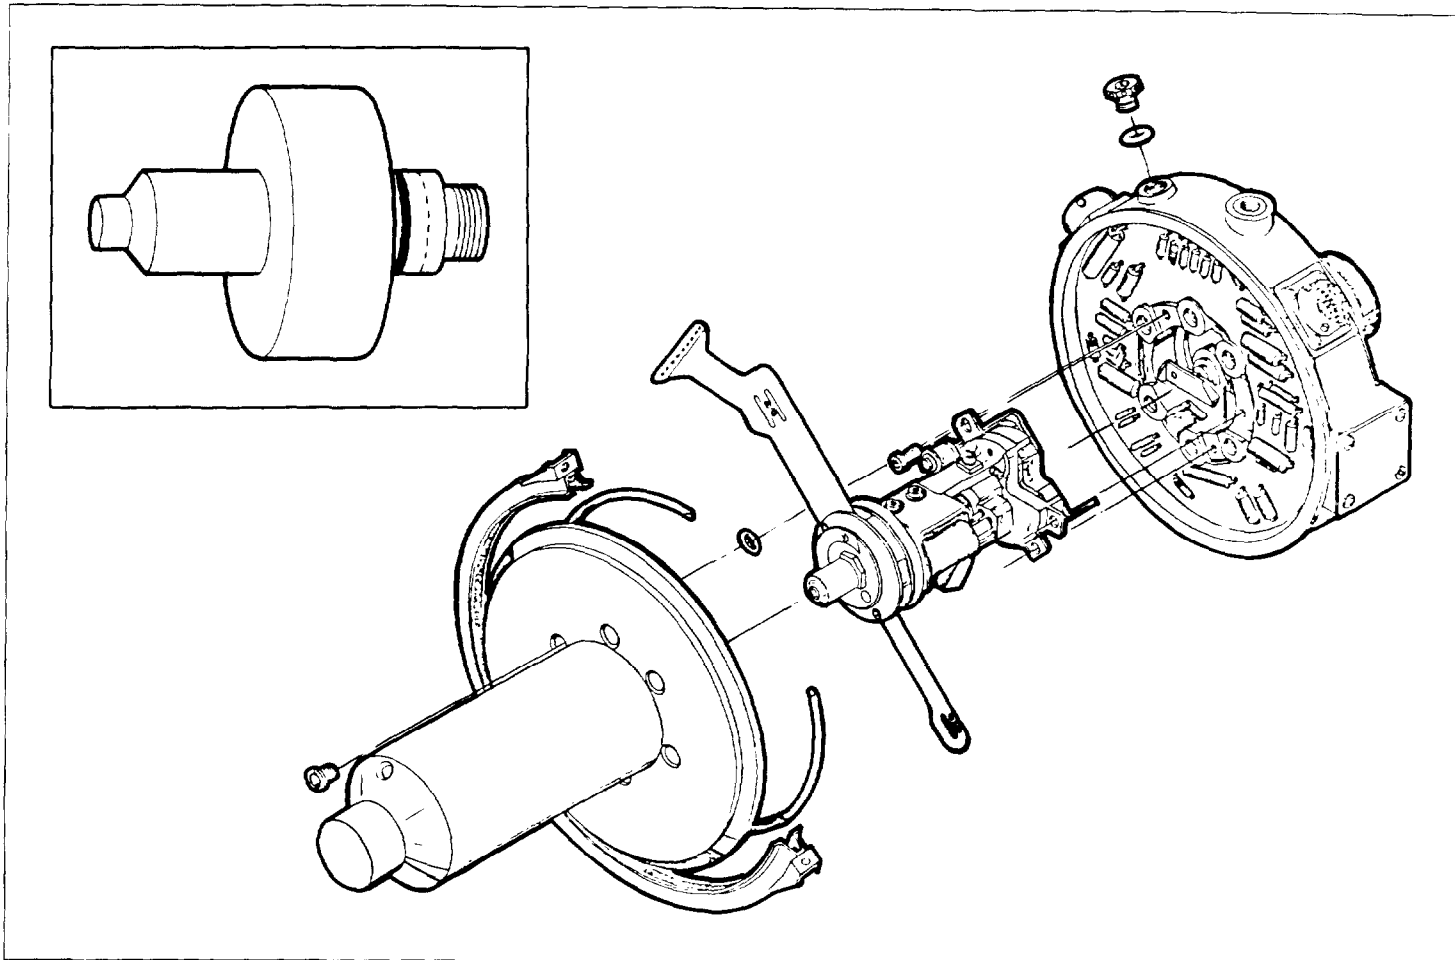
Figure III.2: Drawing of the Safety and Arming Device (FSU-10/A) Assembly

The FSU-10/A Safety and Arming Device (see fig. III.2) provides the ignition and safe-arming function for both the propulsion and warhead sections of the Phoenix AIM-54C missile. FSU-10/A development started in 1977 as part of the Phoenix AIM-54C upgrade. Originally conceived and proposed by the China Lake Naval Weapons Center, the FSU-10/A became a joint effort between the Center and the manufacturer—Micronics International, Brea, California. Under a study contract with the Center, Micronics became responsible for the majority of the design and development work.

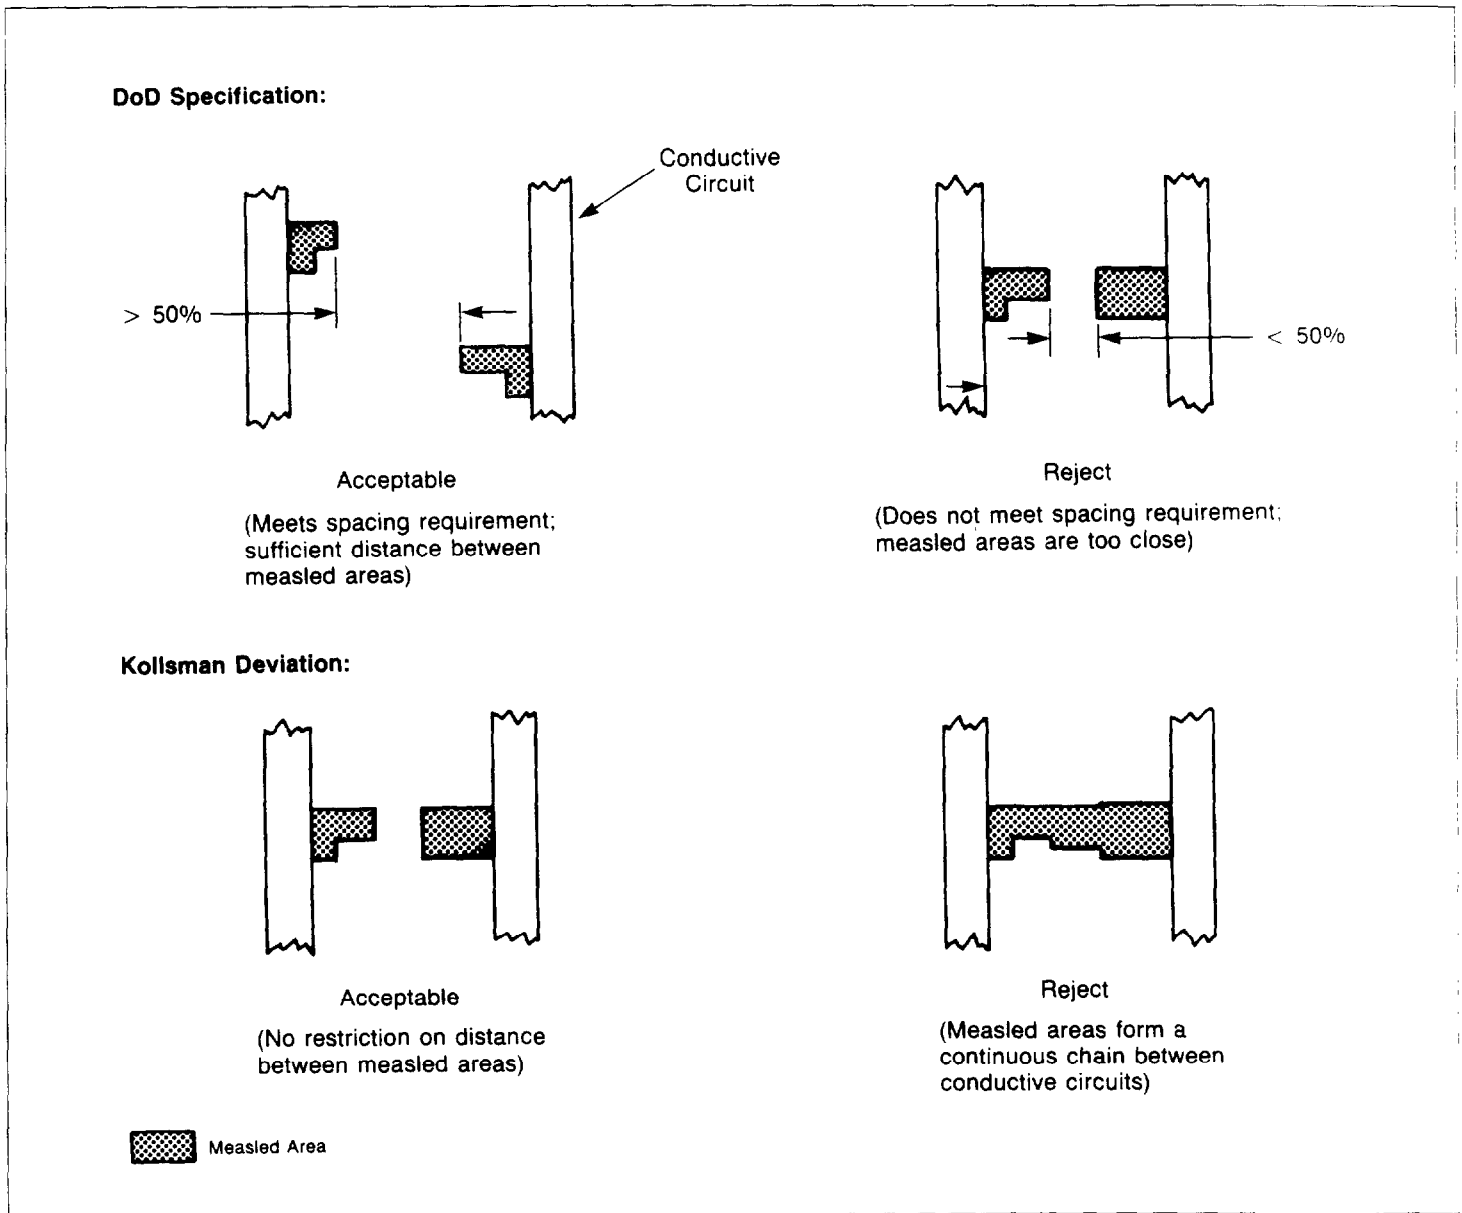
Figure V.2: Harpoon Altimeter Measling Criteria

A temporary 90-day deviation that allowed more measles than authorized under the soldering specification, as long as they did not form a continuous chain between conductive circuits, was approved in April 1986. The restriction in the soldering specification on distance between measles was not included in the deviation. The Navy Plant Representative Office, with NAVAIR's approval, was authorized to accept missiles with the Kollsman altimeters. (Figure V.2 illustrates the difference in the spacing criteria between the DOD specification and the deviation.)

Improvements were made by Kollsman in its processing of printed wiring assemblies, and in August 1986 the temporary deviation was revised and approved to include the WS-6536E spacing criterion. This revised deviation applied to 420 altimeters in the existing purchase order, but it

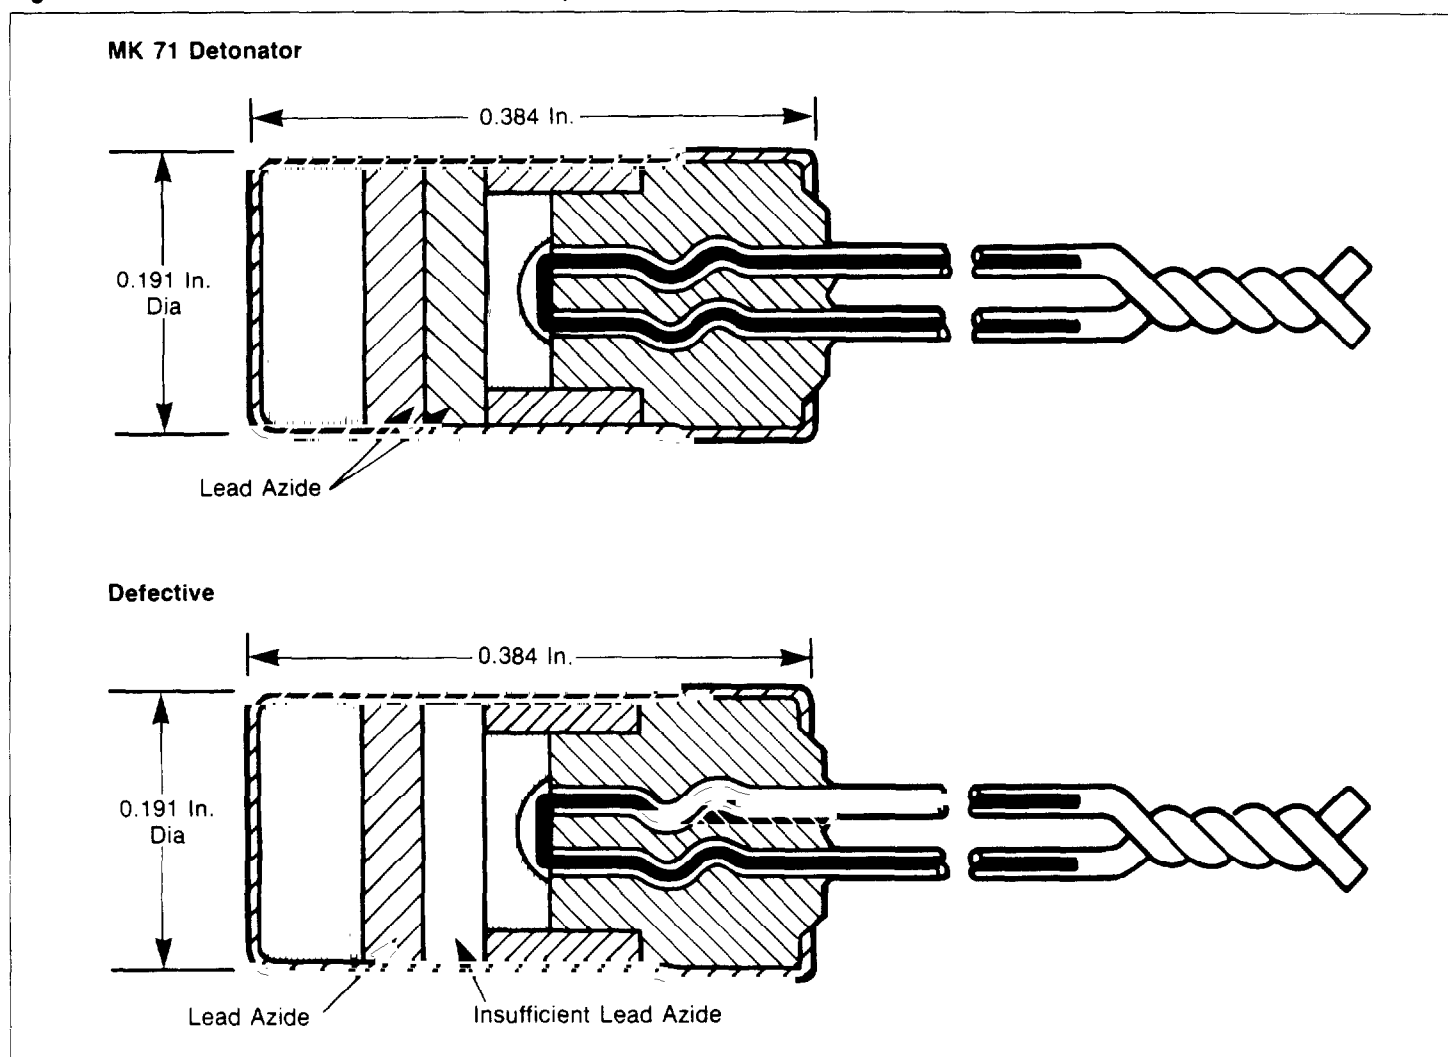
Figure VI.2: Illustration of Normal and Defective Sparrow Detonators

As of July 1987, 3,611 Sparrow safety and arming devices, containing 7,222 of the suspect detonators, had been screened. Of those screened, 225 devices failed because they contained at least one bad detonator. Figure VI.2 illustrates the difference between a detonator with the missing explosive compound (lead azide) and one with all the lead azide.

By September 1987 the Navy had decided to screen additional missile safety and arming devices. This decision was based on the results of tests performed in late August 1987 at the China Lake Naval Weapons
