GAO

MILITARY FASTENERS

Changes to Specifications Are Justified

September 30, 1991

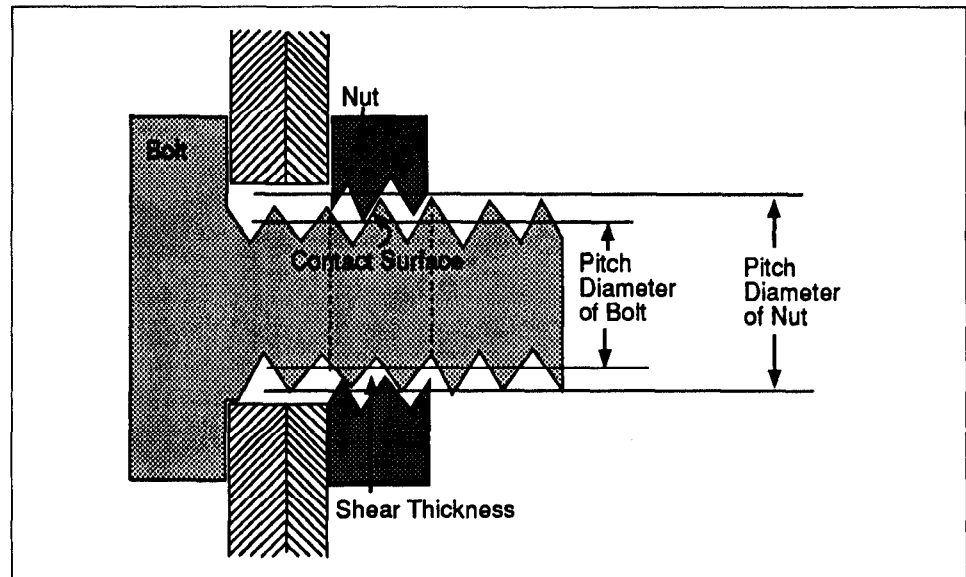
Figure I.2: Cross Section of a Threaded Assembly With an Oversized Nut

Pitch diameter is a measure of size of the threads. It is defined as the diameter of the fastener where the thickness of the thread and the width of the groove between threads are equal. For a nut to assemble onto a bolt, the pitch diameter of the nut must be greater than the pitch diameter of the bolt. Figure I.1 shows a cross section of a threaded assembly using a nut with a correctly sized⁶ pitch diameter, and figure I.2 shows a cross section of a threaded assembly using a nut with an oversized pitch diameter. The oversized nut has less contact surface with the bolt and less shear thickness (the thickness across the width of the thread) than the correctly sized nut.

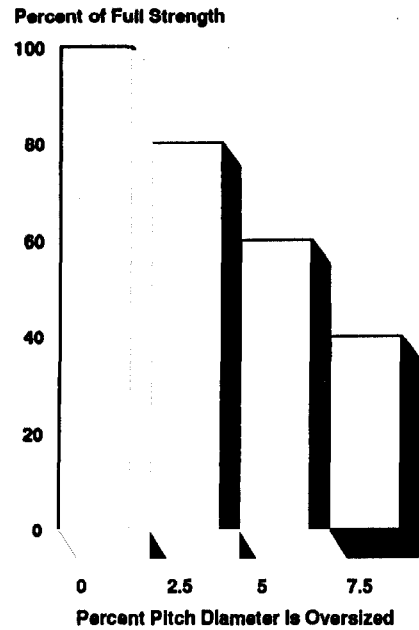
Figure I.3: Thread Strength as Pitch Diameter of Nut Increases

Pitch diameter sizes of the nut and bolt are used to calculate the strength of a threaded assembly. The strongest assembly occurs when the pitch diameter of the nut is slightly larger than the pitch diameter of the bolt. As the pitch diameter of the nut increases, or the pitch diameter of the bolt decreases, the strength of the joint decreases. For example, a 5/8-inch nut oversized by 5 percent will have only 60 percent of the strength of a correctly sized nut. Figure I.3 shows how rapidly strength decreases when pitch diameter deviates from the correct size.

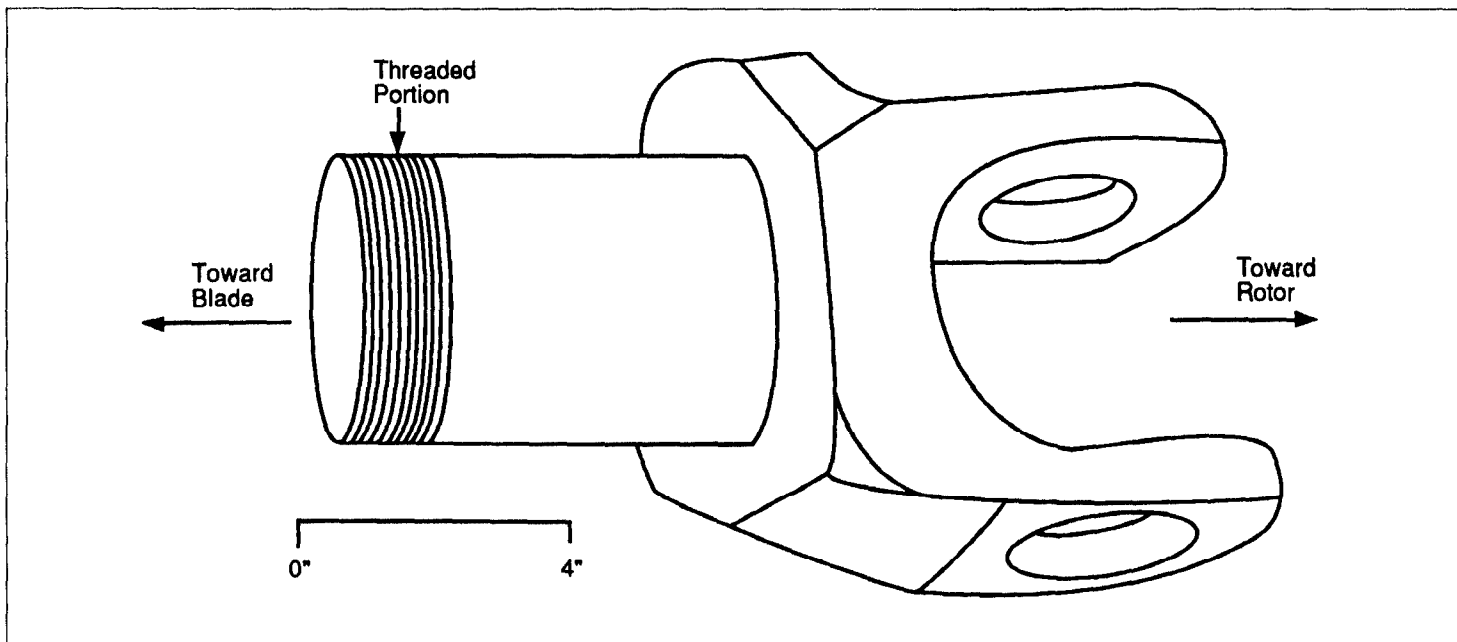
Figure II.1: Helicopter Spindle

The UH-60A Blackhawk helicopter accident occurred on April 15, 1985. The Army Safety Center reported that the spindle (see fig. II.1) on one of the helicopter's main rotor blades failed. The spindle secures the rotor blade to the main rotor (see fig. II.2). The failure was due to a fatigue crack that originated near the root of the first complete thread (see fig. II.3). Spindles are normally replaced every 6,700 hours; however, this spindle failed after only 1,080 hours of use.

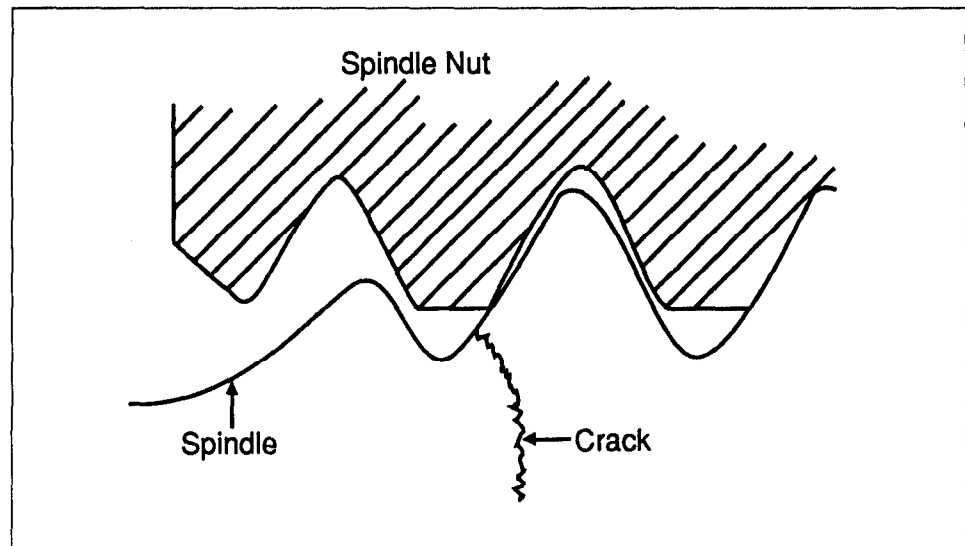
Figure II.3: Origin of Fatigue Crack on UH-60A Helicopter Spindle

The manufacturer of the helicopter examined the spindle and nut assembly for the Army Safety Center. This examination revealed that the threads of the spindle did not meet specifications because of thread waviness (see fig. II.4). This waviness caused the threads of the spindle to come in contact with the mating threads of the spindle nut only in certain areas. This uneven contact pattern compromised the strength of the threaded connection. The manufacturer found no other abnormalities in the spindle.
