GAO

July 1997

AFLOAT PREPOSITIONING

Not All Equipment Meets the Army's Readiness Goal

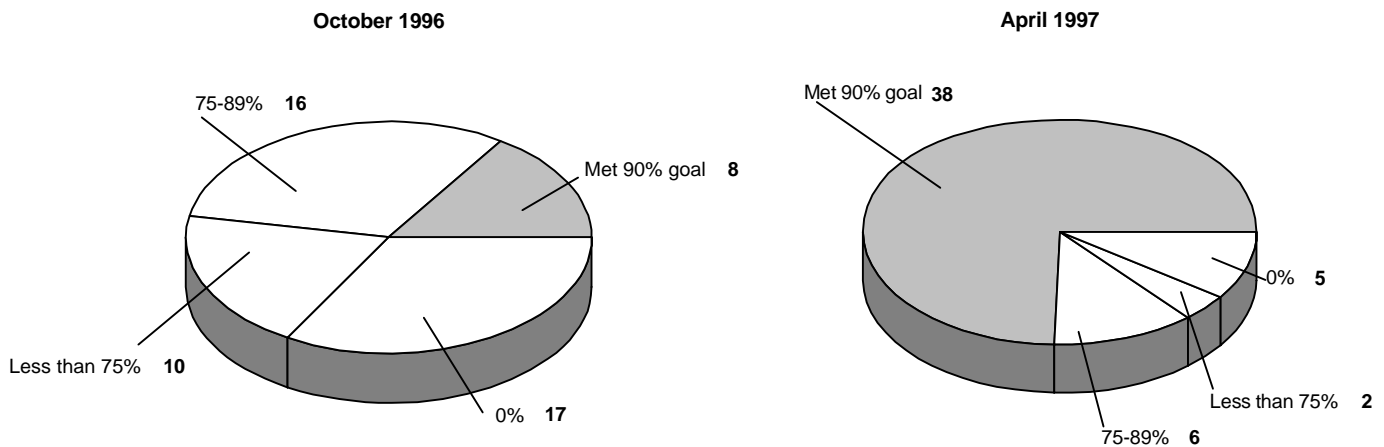
Figure 1: Number of Equipment Sets That Did Not Meet the Army's Readiness Goal in October 1996 and April 1997

As of April 1997, 13 of the 51 unit sets of equipment that are assigned to Army prepositioning ships and considered for readiness reporting, or about 25 percent, did not meet the Army's readiness goal that 90 percent of available war reserve equipment be fully mission capable. Equipment in two unit sets was less than 75 percent fully mission capable, and five unit sets had a fully mission capable rating of zero because they did not have on hand any authorized primary weapon systems or equipment considered critical for accomplishing and sustaining a unit's mission. For example, one unit set designated to support a heavy equipment transport company did not have any of its authorized trucks or trailers.

The status of the equipment in April 1997 had significantly changed from October 1996, when 43 of the 51 unit sets did not meet the Army's goal. At that time, equipment in 10 unit sets was less than 75 percent fully mission capable, and 17 unit sets had a fully mission capable rating of zero because they did not have any of their authorized reportable equipment on hand.

Army officials attributed the improvement as of April 1997 primarily to the transfer of key pieces of equipment considered for readiness reporting from lower priority units not considered for readiness reporting to higher priority units that are considered for readiness reporting.⁵ The officials said that maintenance on the equipment between October 1996 and April 1997 also contributed to the increase in the number of unit sets that met the Army's readiness goal. Figure 1 compares the status of equipment sets in October 1996 and April 1997.

Note: The unit sets that had a fully mission capable rating of zero did not have any reportable equipment on hand.

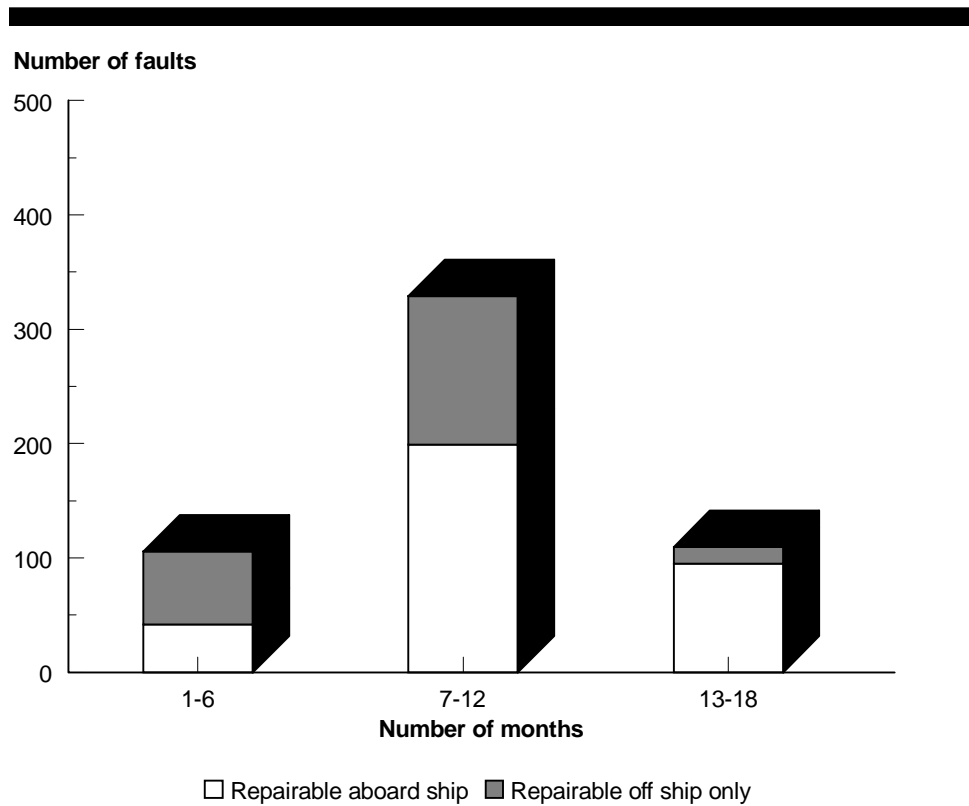
Figure 2: Amount of Time That Uncorrected Faults Have Rendered Equipment Non-Mission Capable (as of Apr. 1997)

The Army's equipment status data, as of April 1997, showed that faults rendering specific pieces of equipment non-mission capable had remained uncorrected since September 1995. Figure 2 shows the amount of time that uncorrected faults have rendered equipment prepositioned afloat non-mission capable and the portion of those faults that the Army considered to be repairable while in storage aboard prepositioning ships.

Note: Data reflects all ships as of April 1997 with the exception of one for which data was only available as of January 1997.

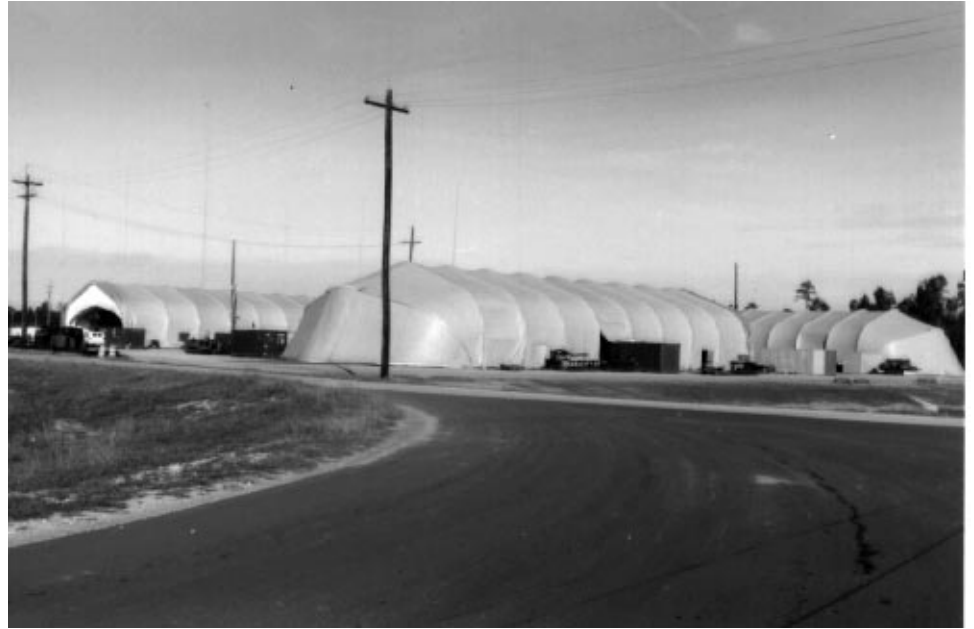
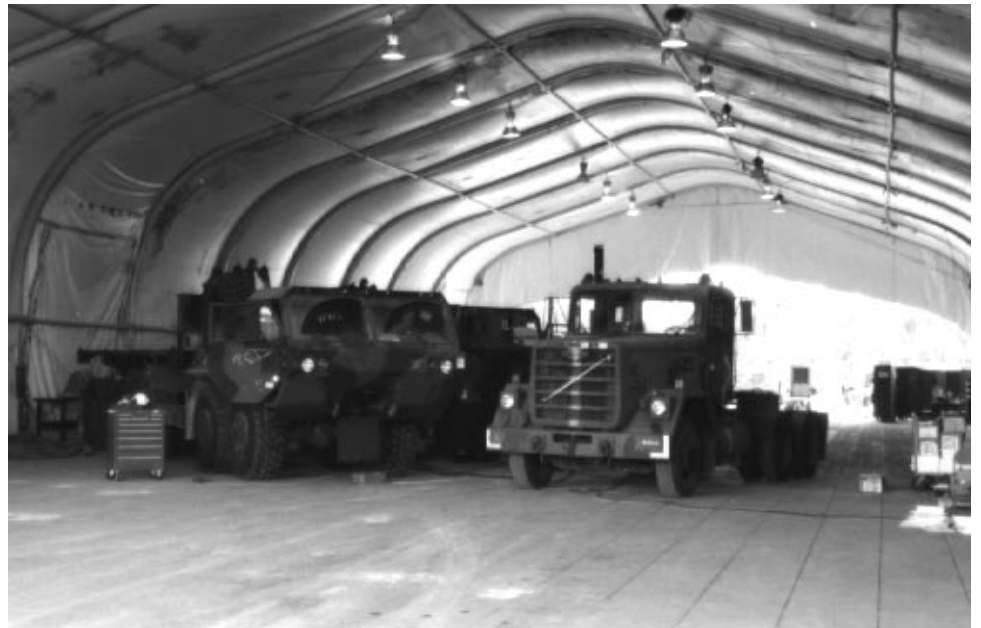
Figure 3: Temporary Maintenance Shelters at the Charleston, South Carolina, Site

The Army received a total of \$45.7 million in fiscal year 1995 and 1996 appropriations for construction of a maintenance facility at Charleston, South Carolina. The site preparation and the initial phase of construction were originally scheduled to be completed before October 1996—in time for the facilities to be used to conduct maintenance on the first full shipload of the brigade set of equipment, which is prepositioned afloat. However, contractors did not complete scheduled construction and renovation projects in time. As a result, the maintenance contractor had to continue to rely on temporary shelters instead (see fig. 3) and had to develop less efficient maintenance processes.

According to Army officials, the construction delays were primarily due to poor soil conditions and the removal of unanticipated hazardous waste, such as asbestos and pigeon droppings, from existing structures.⁹ The officials said that the continued reliance on temporary maintenance facilities did not delay the successful upload of fully mission capable equipment. They also said that the only discernable impact of these less efficient working conditions was a slight but unquantifiable increase in the amount of overtime charged to the contract. The Army plans to complete the transition of maintenance operations from the temporary shelters to the permanent facilities in fall 1997. In accordance with the original facility funding plan, the Army requested \$7.7 million in fiscal year 1998 for further construction at the site, making the total estimated cost for the facility \$53.4 million.
