# NUCLEAR SAFETY

## DOE's Investigation of Phosgene Gas Contamination Was Inadequate, but Experts Conclude That Worker Safety and Facilities Are Not Threatened

Highlights of [GAO-07-712](#), a report to congressional addressees

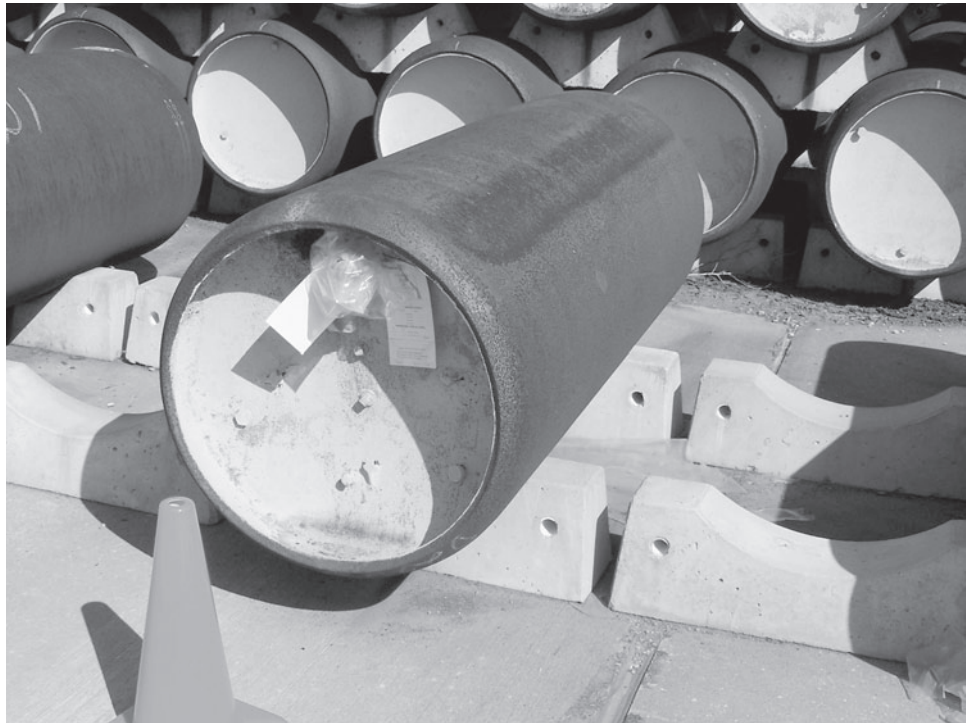
**Figure 1: Uranium Storage Cylinders at DOE's Paducah Site**

Uranium hexafluoride and depleted uranium hexafluoride (the material left over after uranium enrichment) are currently stored in steel cylinders. In all, approximately 700,000 tons of uranium hexafluoride is stored in about 63,000 cylinders at storage yards on the Paducah and Portsmouth sites (see fig. 1). A cylinder surveillance and maintenance program includes regular inspections to check the integrity of cylinder walls, valves, and plugs; replacement or reattachment of nameplates (which are vital for cylinder identification and tracking); and repair of any defective valves or plugs.

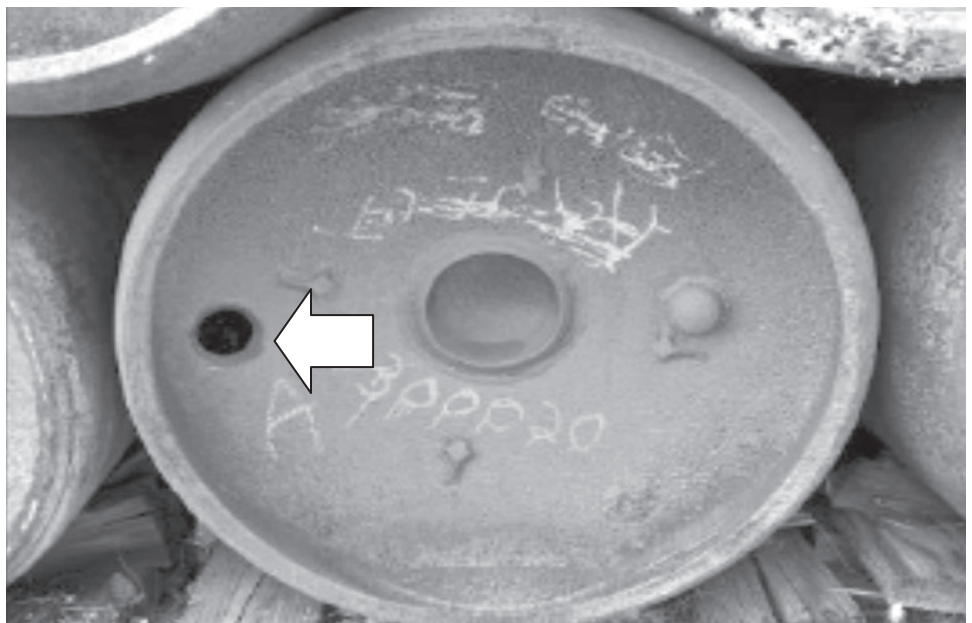
**Figure 2: Cylinder with an Open Hole**

DOE and UDS determined that if any one of these criteria were met, the amount of phosgene that could remain in a cylinder was 1.2 grams or less. For cylinders that did not meet these criteria, DOE and UDS sampled the contents to test for phosgene. On the basis of these procedures, DOE and UDS determined that phosgene could not be present in quantities that would harm the public.
