OCCUPATIONAL SAFETY AND HEALTH

Uneven Protections Provided to Congressional Employees

B-249659

October 2, 1992

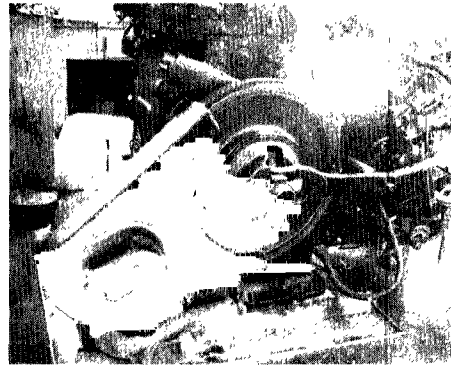
This photograph illustrates the Heidelberg letterpress, GPO #1835. Note the motor transmission/flywheel guard furnished by the manufacturer. The flywheel is partially exposed. Note the operator's arms which are in the normal point of operation.
