Problems In Constructing
Segments Of Interstate
Route 71 In Ohio B-118653

Federal Highway Administration
Department of Transportation

*BY THE COMPTROLLER GENERAL
OF THE UNITED STATES*

MARCH 16, 1972

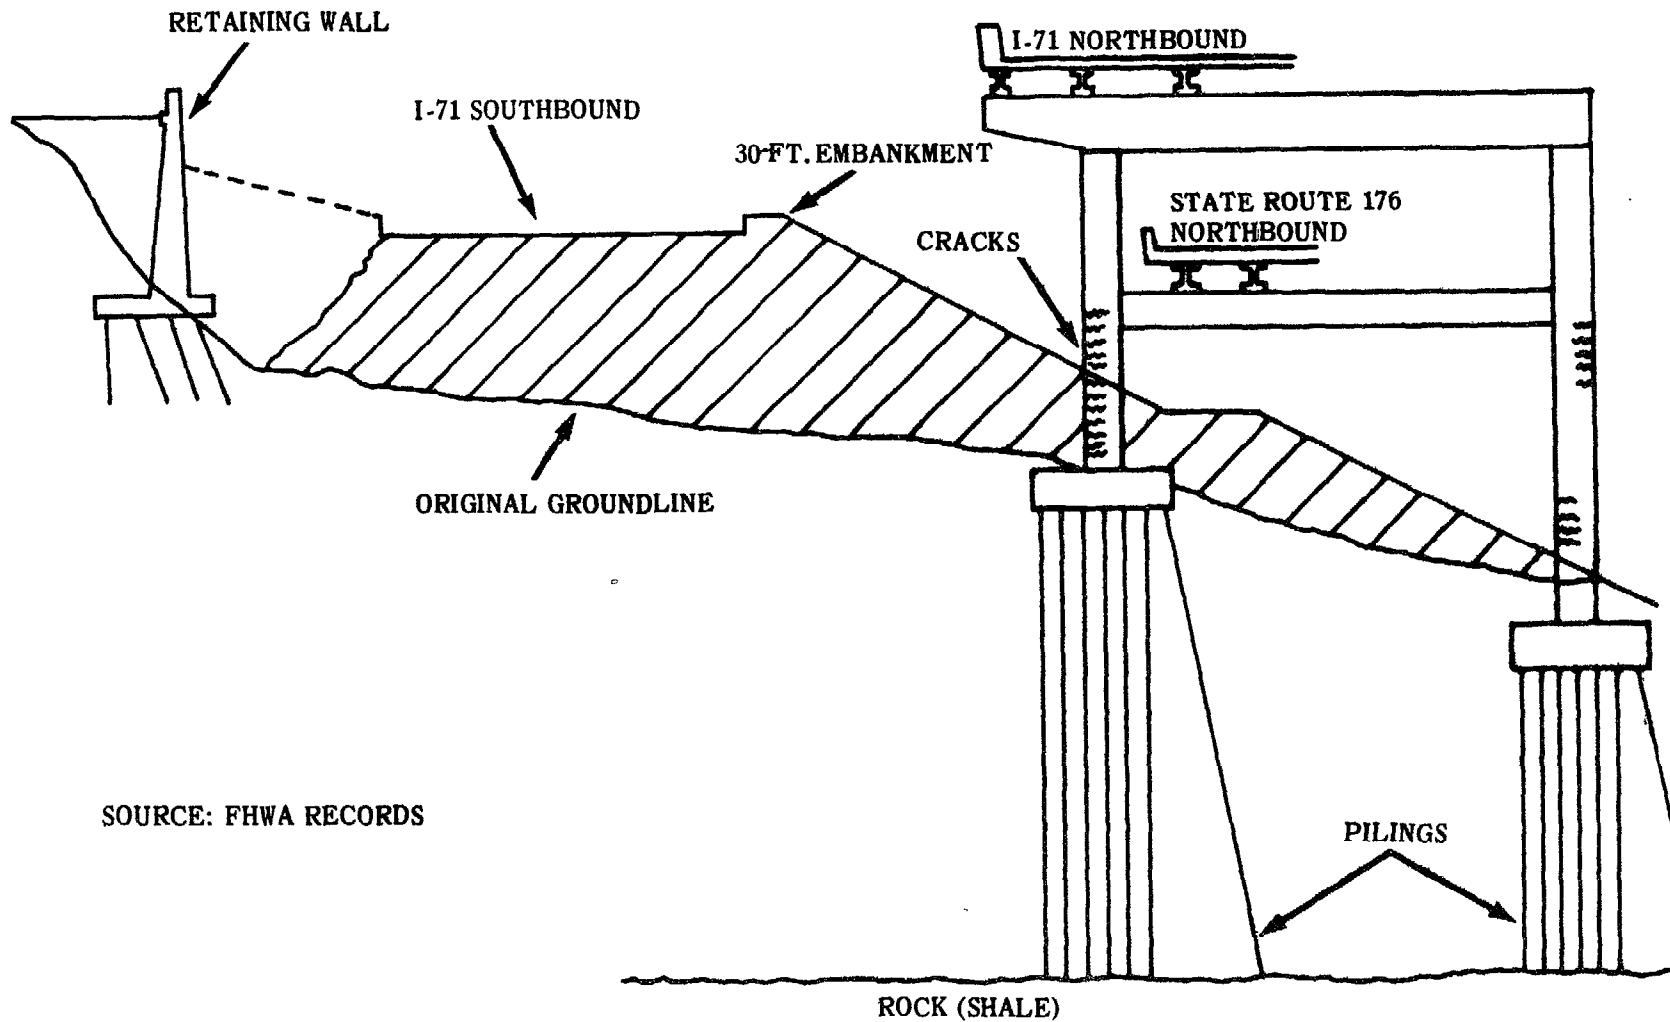
CROSS-SECTIONAL SKETCH
SHOWING PROXIMITY OF PIERS AND EMBANKMENT (AT PIER 16)

In May and June 1966, cracks and/or movements were detected on piers 13 through 19 which support the bridge. Shortly after the damage was detected, the State requested its consulting engineers for the project to determine the extent of damage and the probable cause and to recommend appropriate corrective measures. The consulting engineers, in a report dated July 1, 1966, stated that the probable

cause of the damage was the consolidation of the underlying subsoils of the 30-foot embankment that produced an underground lateral movement which acted against the piles supporting the piers. (See sketch on p. 16.)

The damaged piers subsequently were repaired, and the State requested Federal participation in the repair costs. FHWA agreed to participate in these costs, except those associated with pier 19, the cost of which had not been allocated. The total cost to stabilize the embankment and repair the piers amounted to about \$1.4 million.

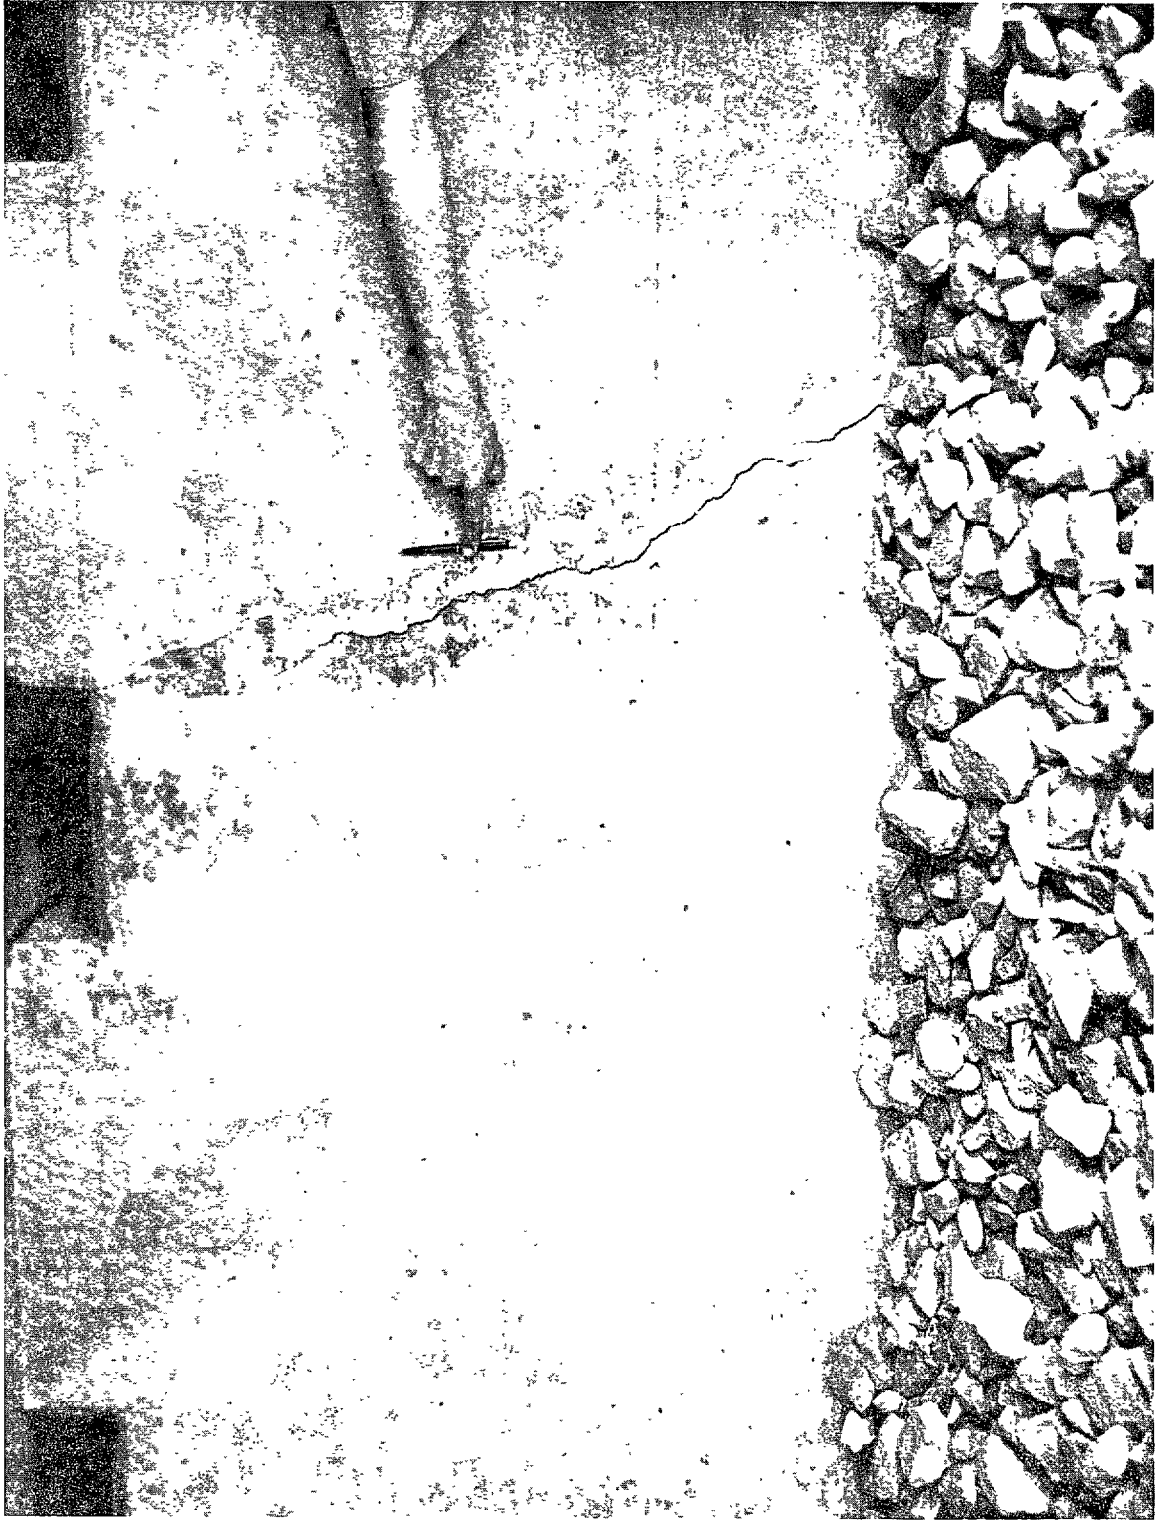
Crack on bridge abutment.

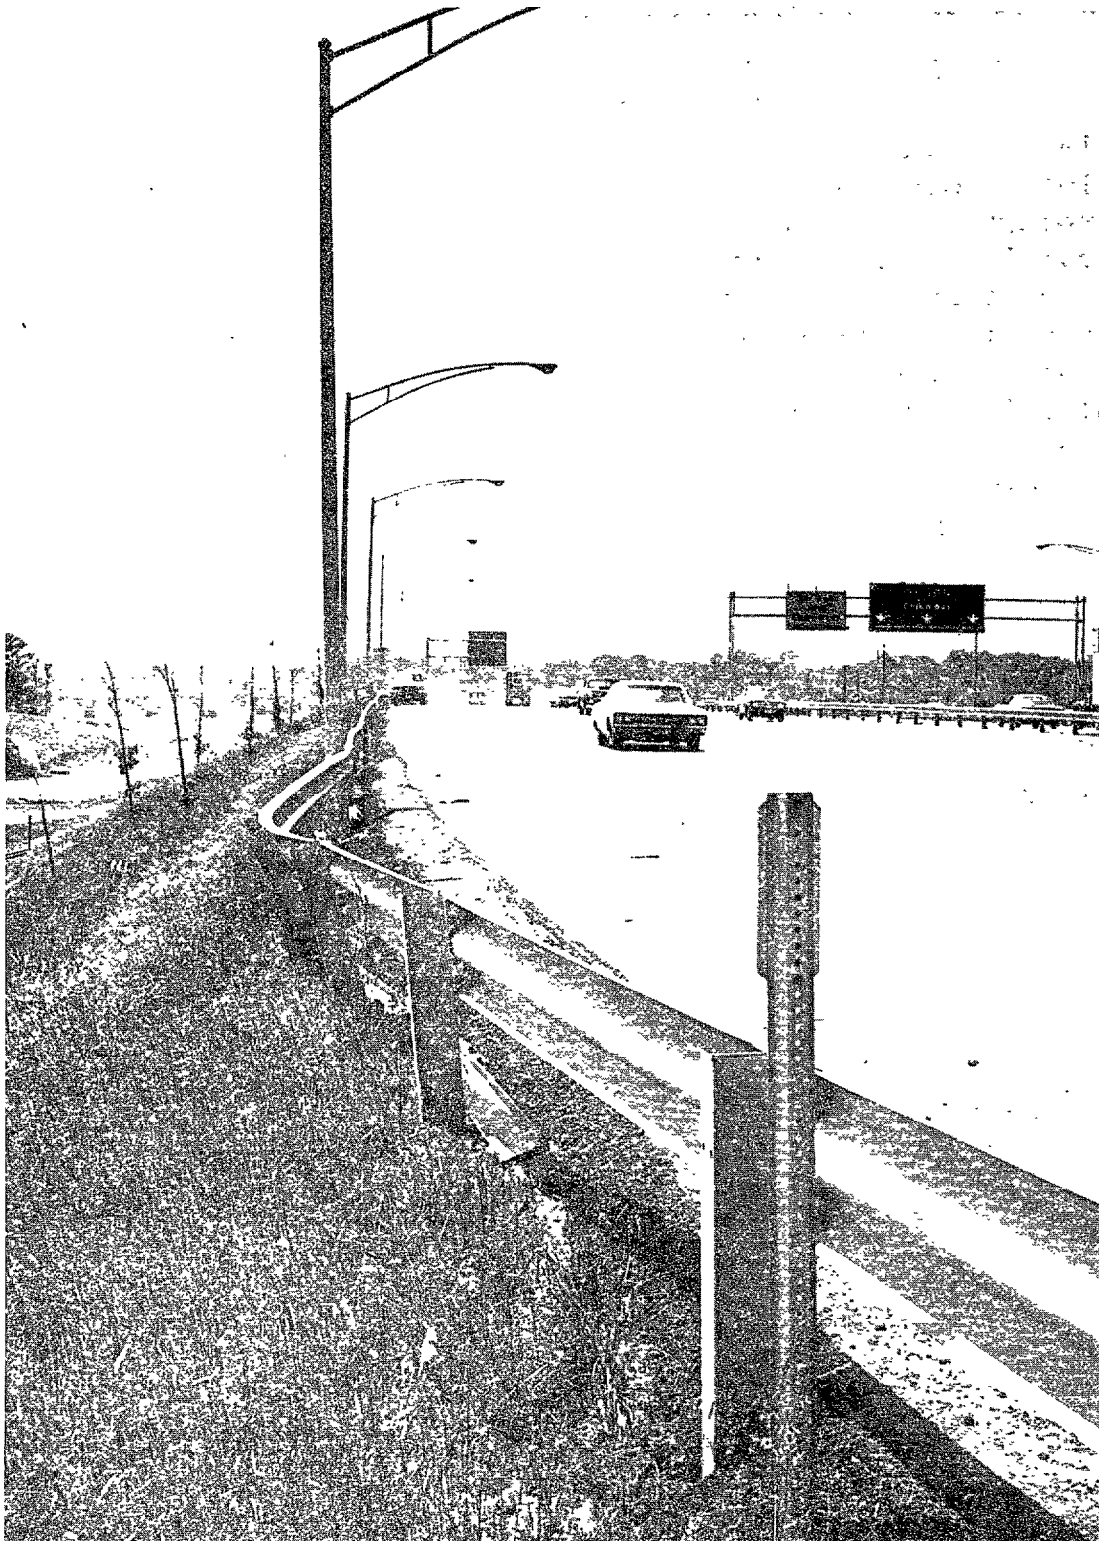
Guardrail and lighting fixtures sliding as a result of compaction of embankment on landfill.
