United States General Accounting Office

Report to the Honorable
Bill Schuette, House of Representatives

BRIDGE SAFETY

Structural Soundness of the Zilwaukee Bridge

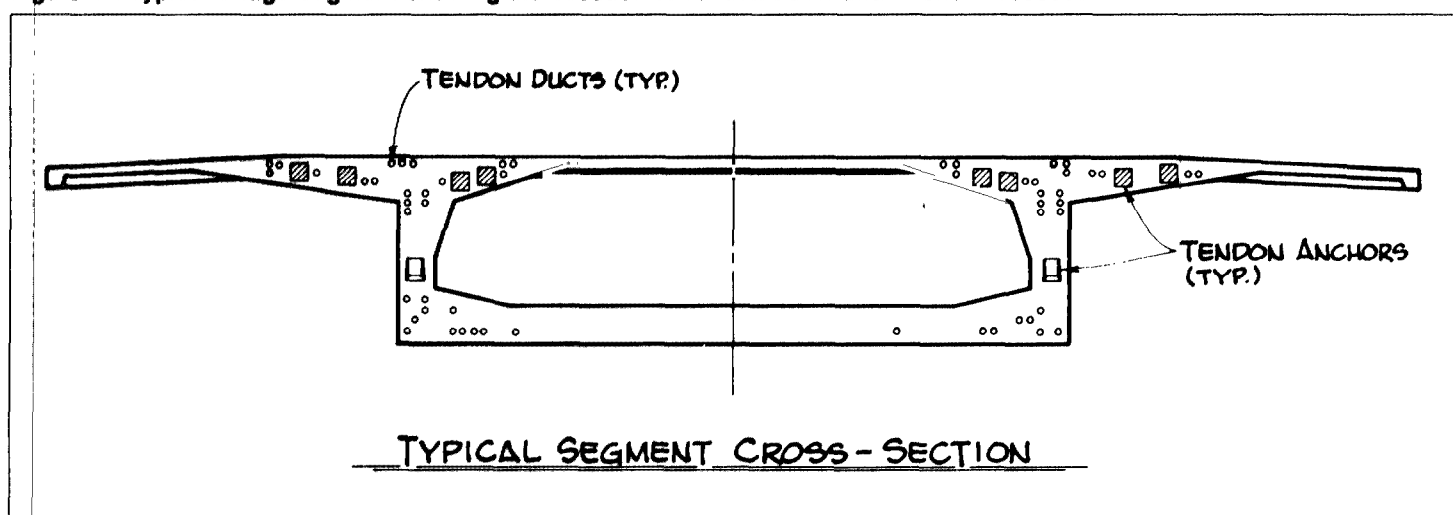
Figure I.1: Typical Bridge Segment Showing the Location of Tendon Ducts and Anchor Recesses

Some spans of the Zilwaukee Bridge were damaged by concrete spalling during the winters of 1985-86 and 1986-87. This damage caused considerable public controversy and debate over the bridge's strength and durability. An independent engineering report prepared for the Detroit News in 1987 suggested that the concrete spalling might be the result of point loading (uneven pressure along the joints between the concrete bridge segments) or low-strength concrete, and could indicate structural weakness. However, MDOT, HNTB, the contractor, the contractor's engineering consultant, and FHWA maintained that the spalling was caused by freezing water trapped in tendon ducts and anchor recesses in the bridge and did not affect the bridge's strength or durability. (See fig. I.1.)

As discussed below, we found no evidence to support the suggestion that the spalling was the result of point loading or low-strength concrete. However, the evidence does strongly support the position that the spalling was caused by freezing water trapped in tendon ducts and anchor recesses.

The fact that most of the spalling occurred during winter months does support the position that water became trapped in tendon ducts and anchor recesses and froze, building up pressure (water expands in volume as it freezes) that caused the concrete around these locations to spall. These ducts and anchor recesses were supposed to be sealed with grout within 30 days after the construction of a span was completed.² However, because grout cannot be used during cold weather, tendon ducts and anchor recesses in spans of the northbound bridge were not sealed on time when the contractor elected to continue construction into the winter of 1985-86. Similarly, tendon ducts and anchor recesses in partly completed spans of the southbound bridge could not be sealed with grout when the contractor ceased construction during the winter of 1986-87. According to MDOT, the tendon ducts and anchor recesses in the unsealed spans of the bridge were not properly protected, and water trapped in these spaces froze and expanded, causing the surrounding concrete to spall.

enough to freeze any water trapped in tendon ducts and anchor recesses. In addition, we found that most of the spalling was located around unsealed tendon ducts and anchor recesses where water was most likely to become trapped. In fact, MDOT inspectors' reports noted that water was present in the anchor recesses in some cases when repair crews removed the loose concrete in the spalled areas prior to making repairs. Often the anchor recesses were clearly visible near the center of the spalls once the loose concrete was removed.
