LOMA PRIETA EARTHQUAKE

Collapse of the Bay Bridge and the Cypress Viaduct

B-237961.3

June 19, 1990

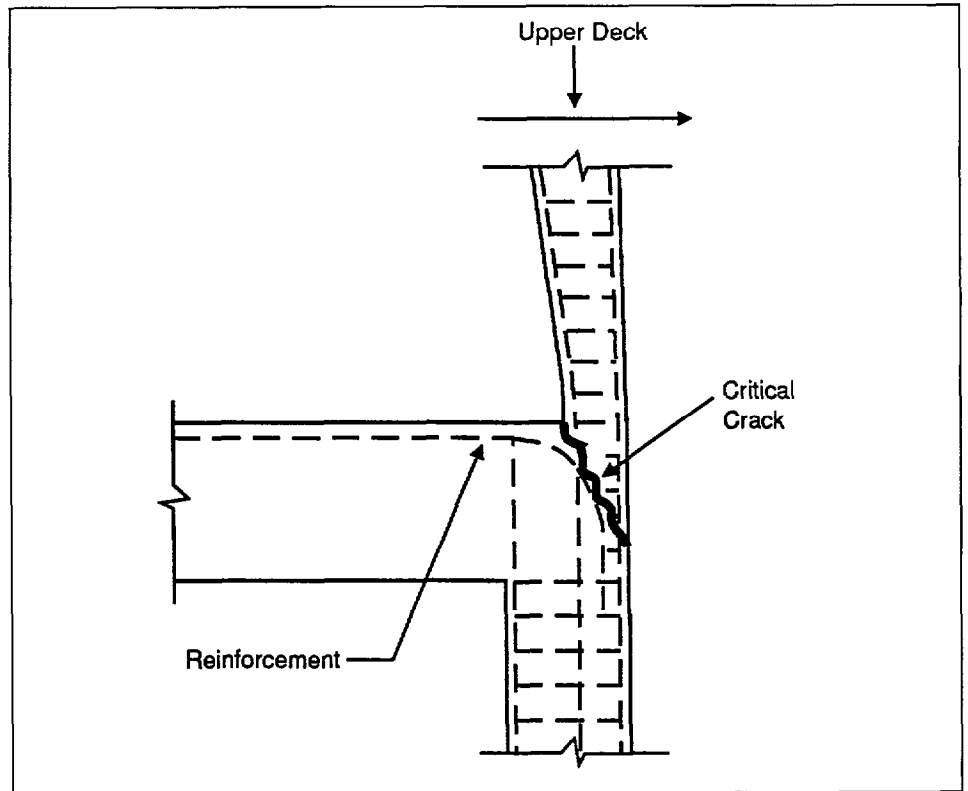
Figure I.2: Illustration Depicting
Reinforcement in Cypress Viaduct
Columns

After studying the collapse, CalTrans engineers now believe that the Cypress Viaduct had an additional, more serious weakness in its columns which, when combined with the amplified shaking motions in the soft soils underlying the structure, led to its collapse. (See app. III for a discussion of earthquake force measurements.) According to CalTrans engineers, the reinforcement provided at the point where the columns joined the lower deck—the pedestal section—was insufficient to prevent the columns from breaking. (See app. I, figs. I.2 and I.3.) It was at this point that many of the columns sheared off, causing parts of the upper and lower decks to collapse. (See app. I, figs. I.4. and I.5.)

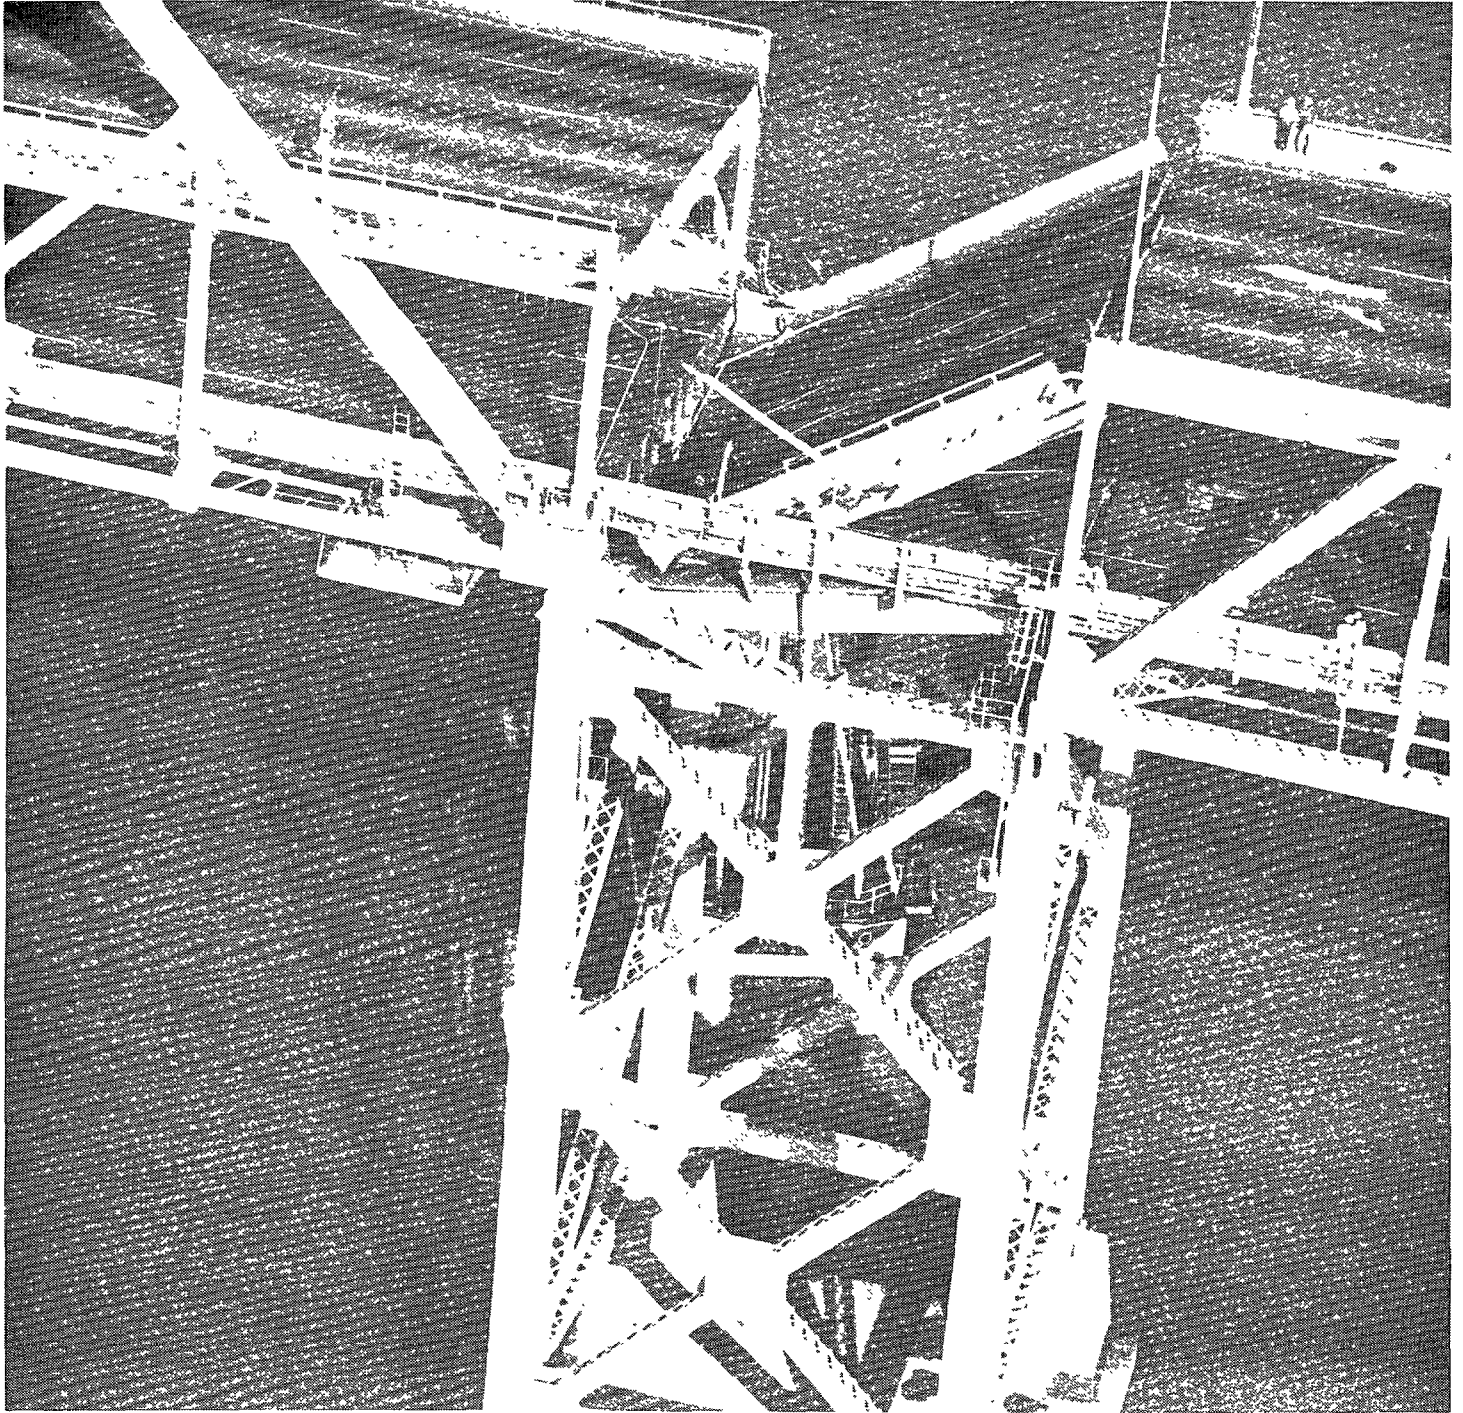
Figure I.6: Collapsed Section of the San Francisco/Oakland Bay Bridge

The collapsed section broke off of one of the strongest piers supporting the east bay section of the bridge. This pier was designed to absorb the energy of an earthquake and prevent shocks to other points along the bridge. According to CalTrans engineers, the unanticipated magnitude of the horizontal motion caused by the Loma Prieta Earthquake broke the bolts holding the span to this pier, causing it to fall. (See app. I, fig. I.6.)

CalTrans officials believe that a detailed structural analysis could have detected this section’s weakness. However, the bridge was not considered vulnerable and, before the Loma Prieta Earthquake, such analyses were not performed because of their cost and complexity and because of the limited funds available. The analysis involves a computer simulation of how various shocks would affect about 27,000 possible stress points along the bridge’s 8.3-mile length. CalTrans is now planning to conduct
