CED-76-148

**Construction Problems With
Country Club Estates
Merrimack, New Hampshire—A
Section 235 Housing Project**

Department of Housing and Urban Development

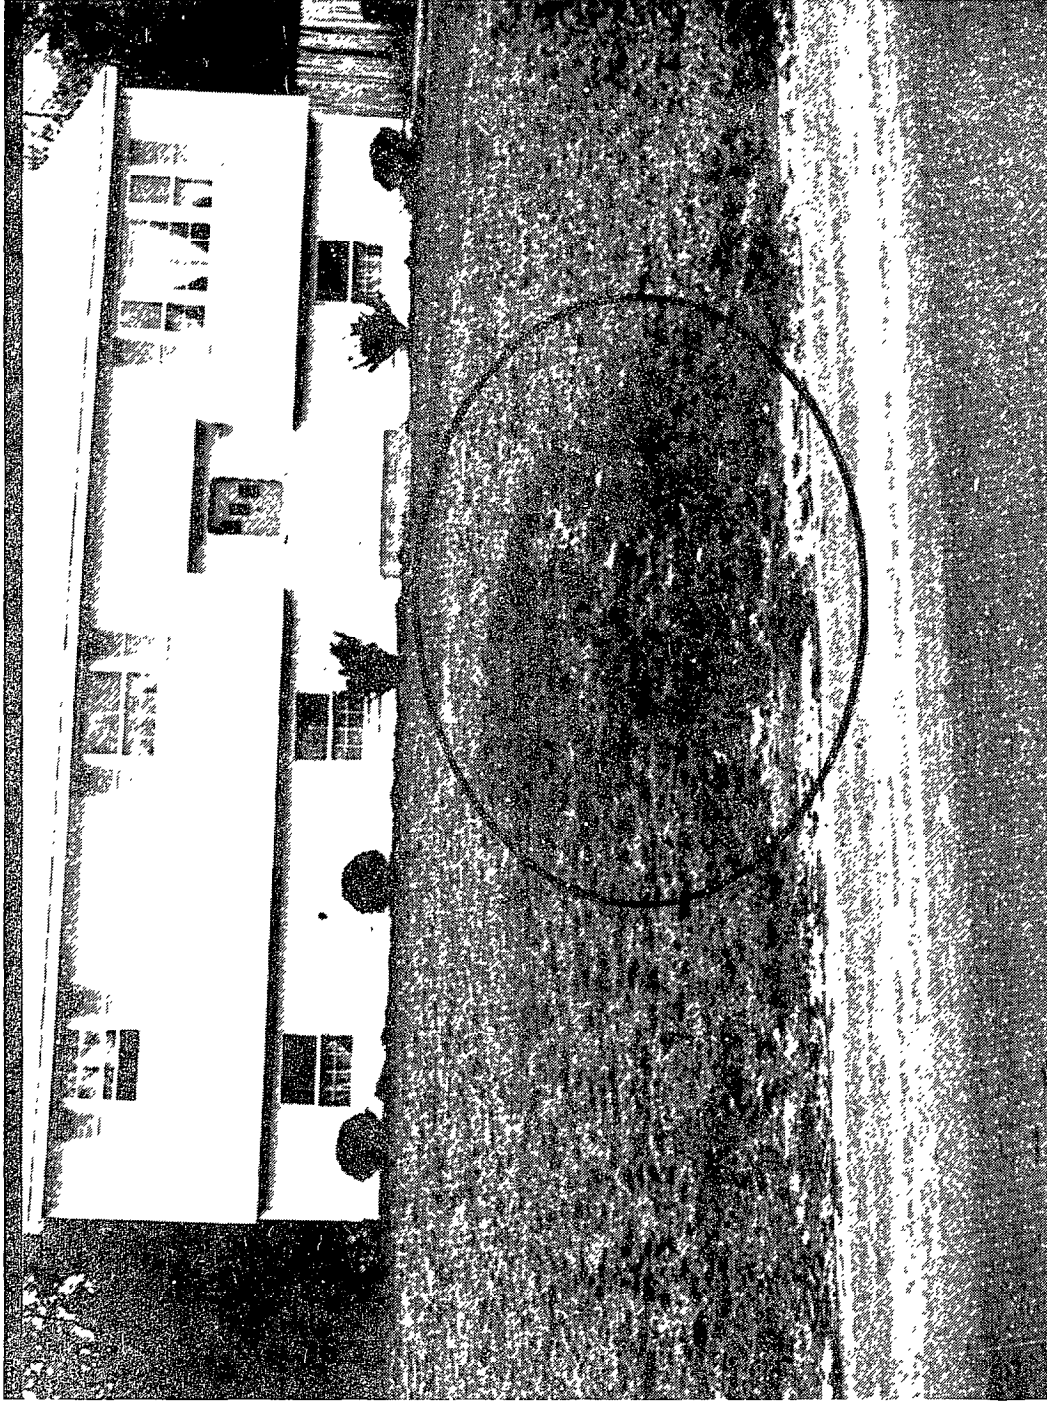
House B--The homeowner of house B had a problem with the septic system. The absorption bed, located in the front of the house, constantly leaked to the surface and had been doing so since the spring of 1972. The homeowner said that the leakage was greater in the spring. He also said that there was a foul odor in the summer months. He said that after heavy rains the water from the absorption bed ran down the street. We saw a grassy area which was wet and which appeared to be caused by a septic system failure.

The photograph on page 8 shows the leaking septic system we observed during our visit.

HOME B. DARKENED AREA IS THE LOCATION OF THE LEAKING SEPTIC SYSTEM

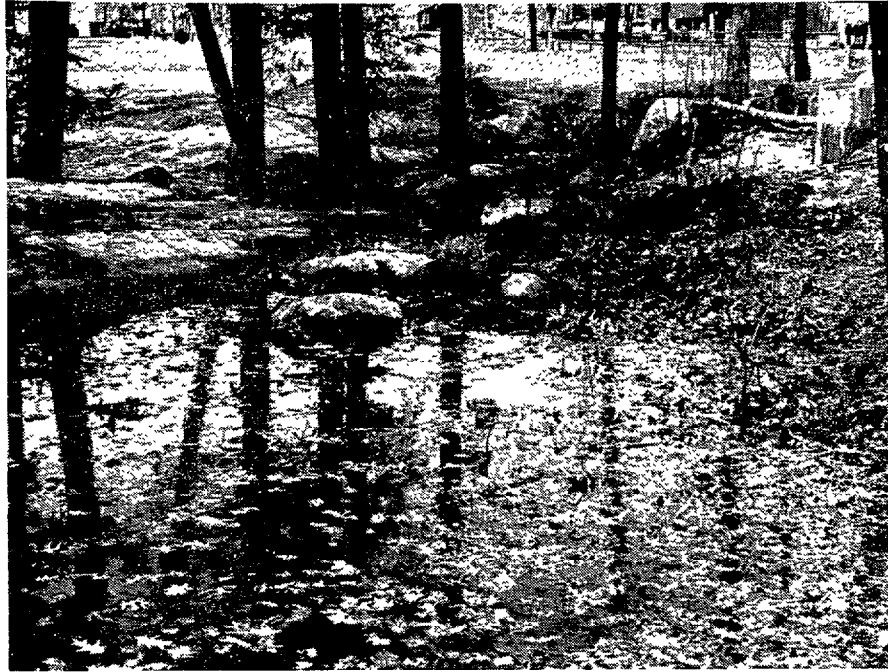
The homeowner said that a pool of standing water formed near the house because of improper culvert construction. (See photograph on p. 9.) She said that on occasion the pool covered an area about 20 feet by 30 feet and was about 5 feet deep. The homeowner said that the pool of water posed a dangerous situation because potential for a drowning existed and because it was polluted by the septic system. She said that during the summer months the area almost dried up.

HOME C.--PONDED WATER WHICH FORMS BESIDE THE HOUSE.

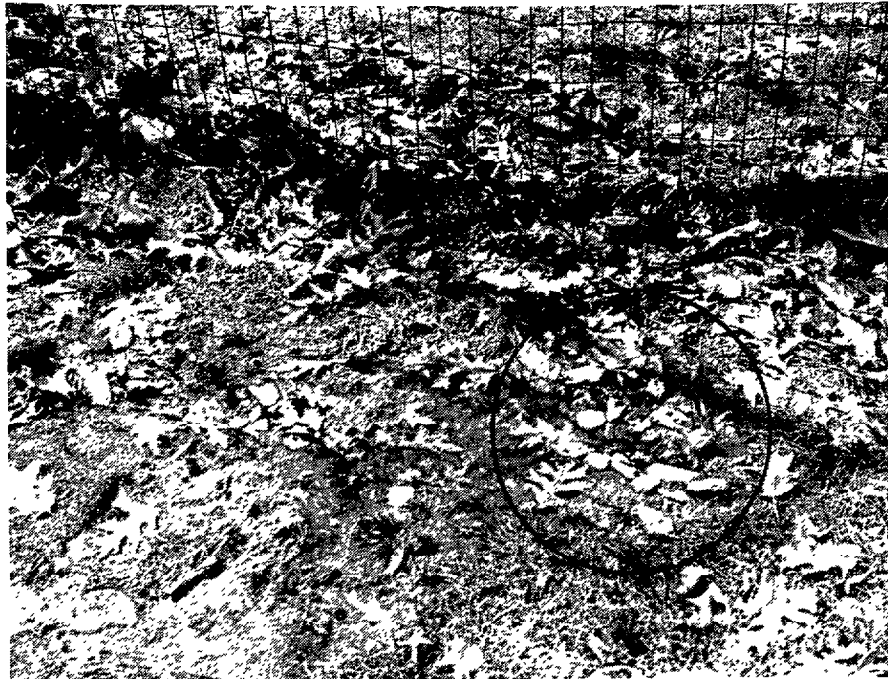
During our visit we noted that a corner of the absorption bed was exposed and stones were visible and that, when the toilet was flushed, water from the system bubbled to the surface and ran down the slope of the yard to a drainage trench. The homeowner noticed a foul odor in the fall of 1971 and initially attributed it to an adjacent swampy area. The foul odor became more noticeable in the spring of 1972 and still exists. The homeowner told us that she washed clothes at night, to minimize the effect of the unpleasant odor on the neighborhood.

HOME C.— CIRCLED AREA IS EXPOSED CORNER OF ABSORPTION BED. WHEN THE TOILET IS FLUSHED, WATER FROM THE SYSTEM PERCOLATES TO THE SURFACE AND RUNS DOWN THE SLOPE OF THE YARD.

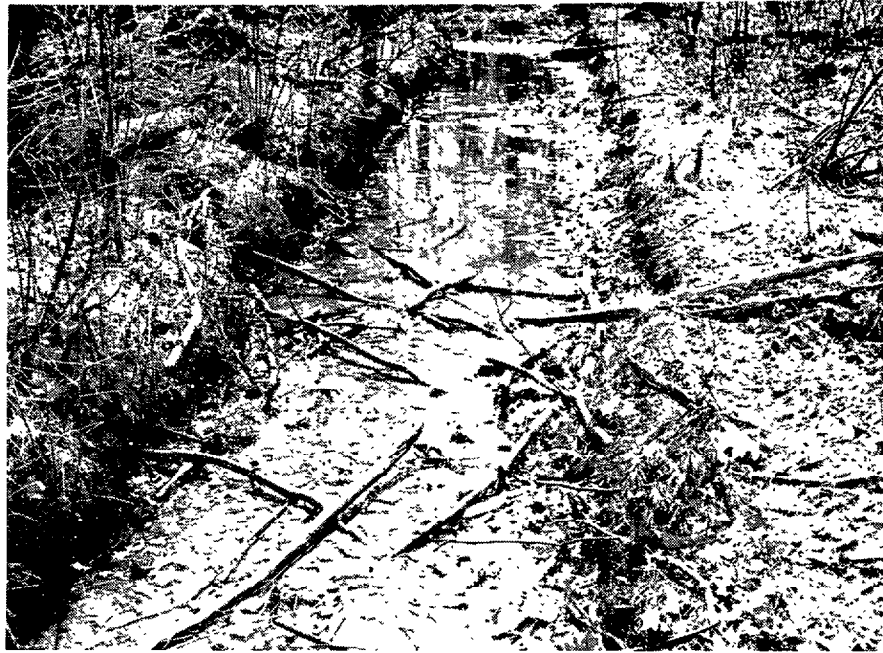
In July 1975 HUD's Boston regional sanitary engineer inspected the subdivision for reported problems concerning septic systems. His report indicated that throughout the subdivision there were over 4,000 feet of open channels with very poor drainage, as evidenced by the pools of water in culverts at road crossings and drain inlets. He said that this condition was contributing to the high groundwater table in this subdivision. A photograph showing open channel drainage is shown on page 11.

**OPEN CHANNEL DRAINAGE DITCH NEAR A HOMEOWNER'S PROPERTY.
A SIMILAR DITCH EXISTS AT THE REAR OF THE PROPERTY.**

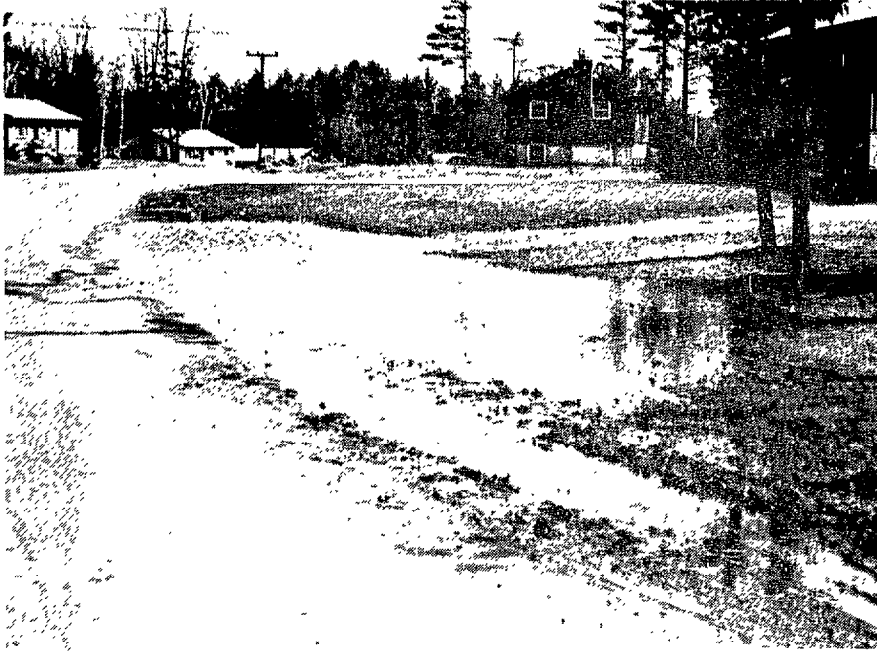
SURFACE WATER 2 DAYS AFTER A RAINSTORM.

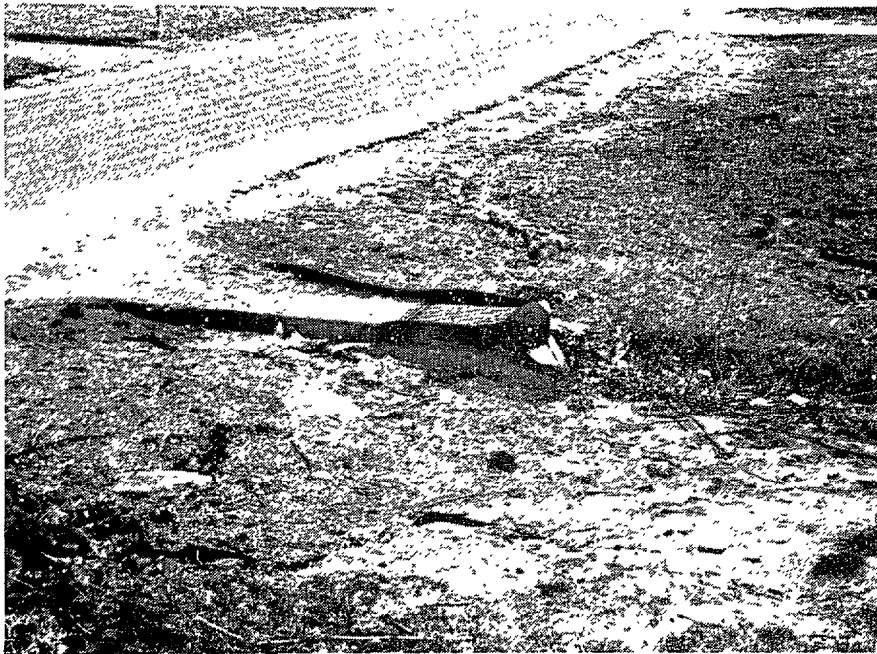
STORM WATER DAMAGE TO HOMEOWNER'S FRONTYARD.

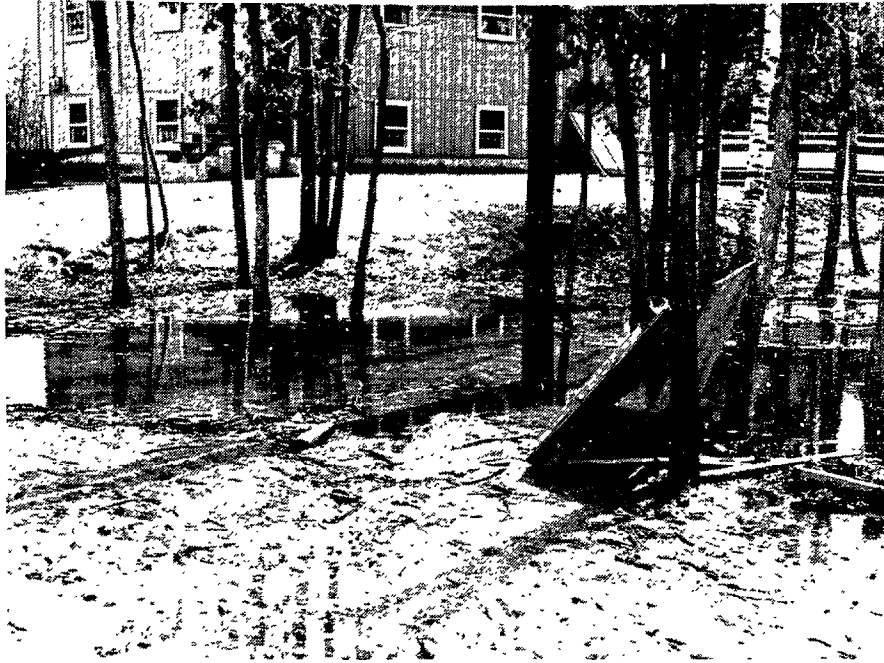
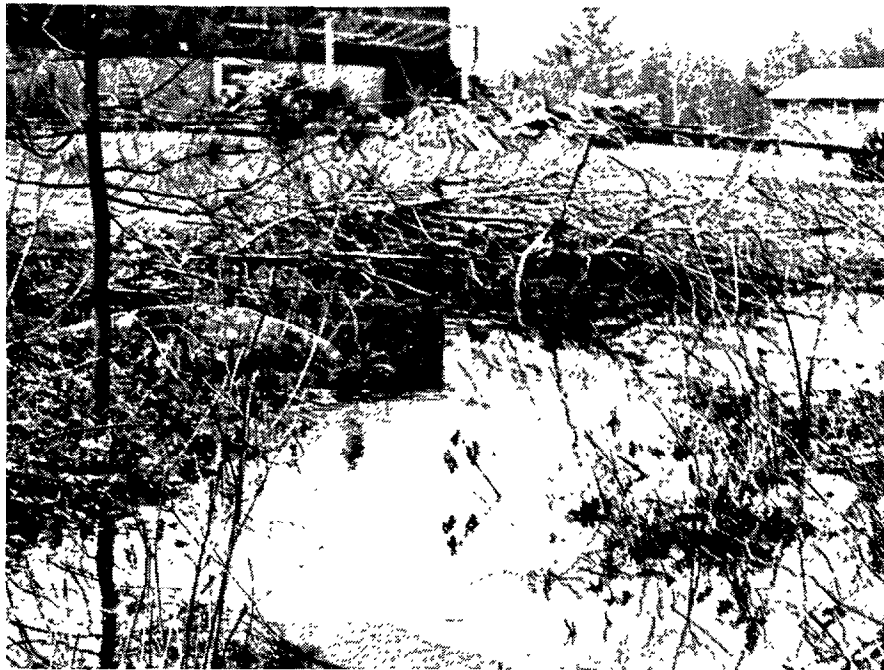
PONDED WATER SEVERAL INCHES DEEP IN TWO HOMEOWNERS' BACKYARDS.

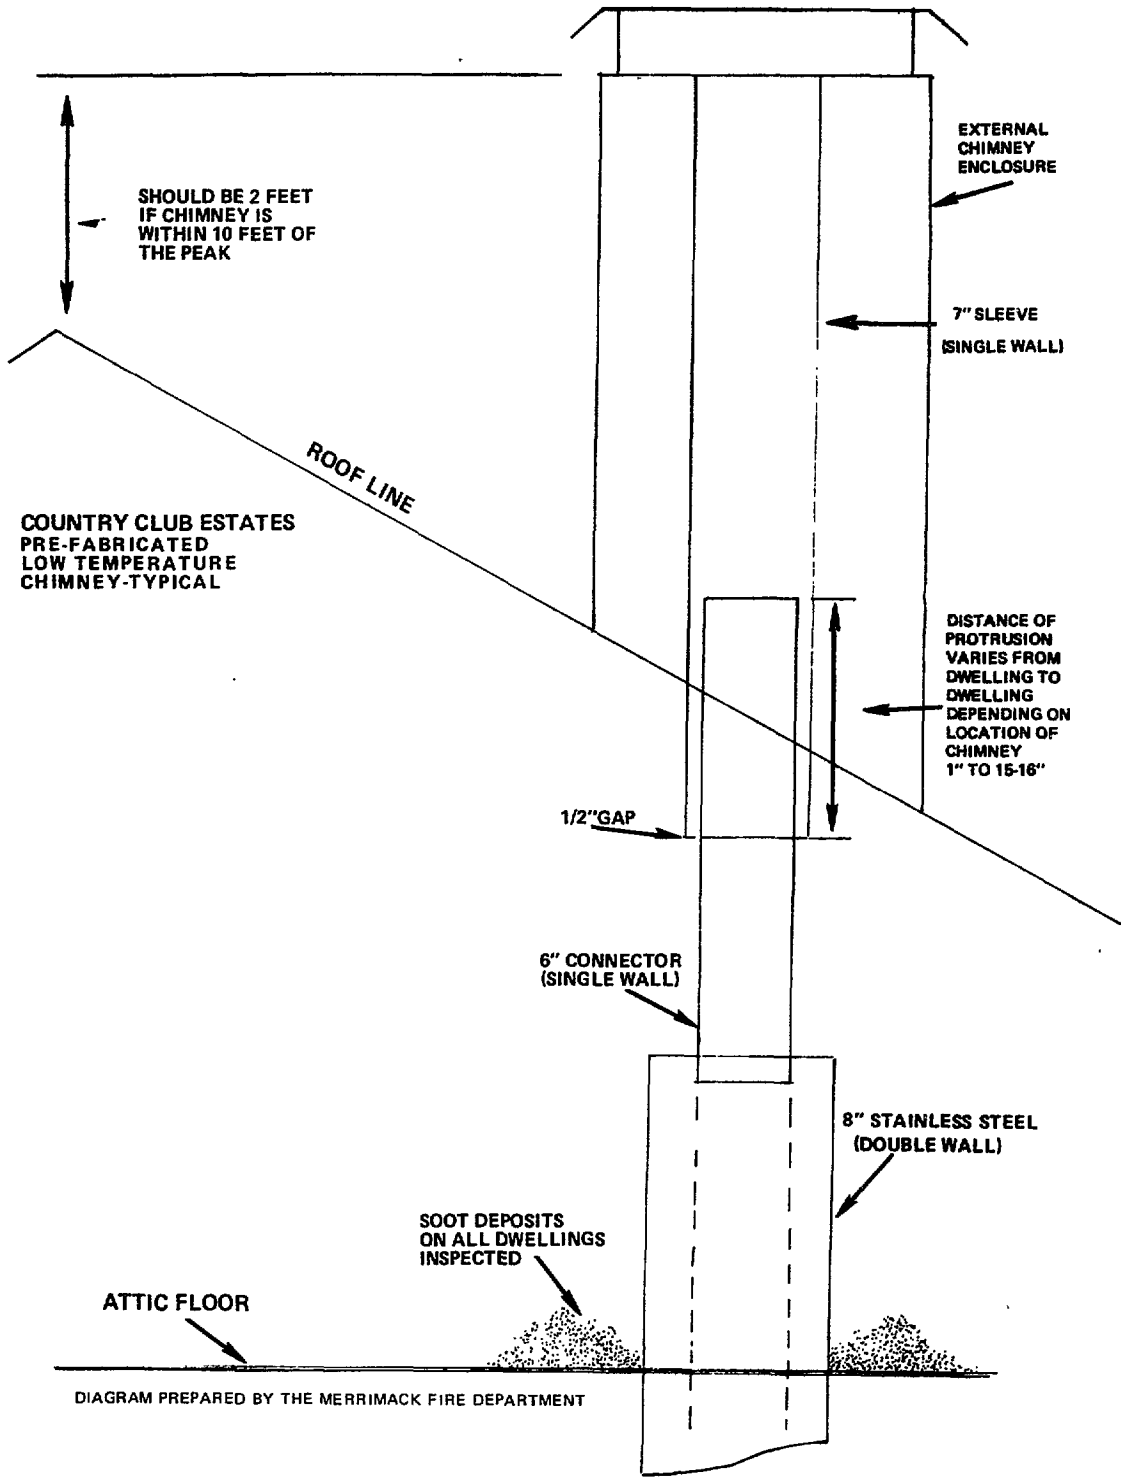
COUNTRY CLUB ESTATES
 PRE-FABRICATED
 LOW TEMPERATURE
 CHIMNEY-TYPICAL

The double-walled chimney in question is reduced to a single-wall piece of metal flue pipe (6 inches in diameter in the attic) which extends into a 7-inch sleeve of the exterior chimney. Where the smaller pipe connects to the larger pipe, there is a 1/2-inch gap which allows soot to escape. The Merrimack Fire Department, in a report dated January 14, 1976, said that this condition represented a fire hazard should a downdraft occur and force a hot carbon spark onto the attic floor. A fire department official told us that although under normal conditions the chance of a fire would be remote, a malfunctioning furnace would increase the chance of a fire. He also said that, if a homeowner attached a wood-burning stove, the fire hazard would be increased. In addition, the fire department reported that many of the external chimneys included in its inspection did not extend to points at least 2 feet above the highest parts of the roofs. None of these chimneys meet the minimum property standards because double-wall construction does not extend from the furnace to the roof, the chimney does not extend at least 2 feet above the highest part of the roof, and soot is allowed to escape. A diagram of the chimney installation is shown on page 24.

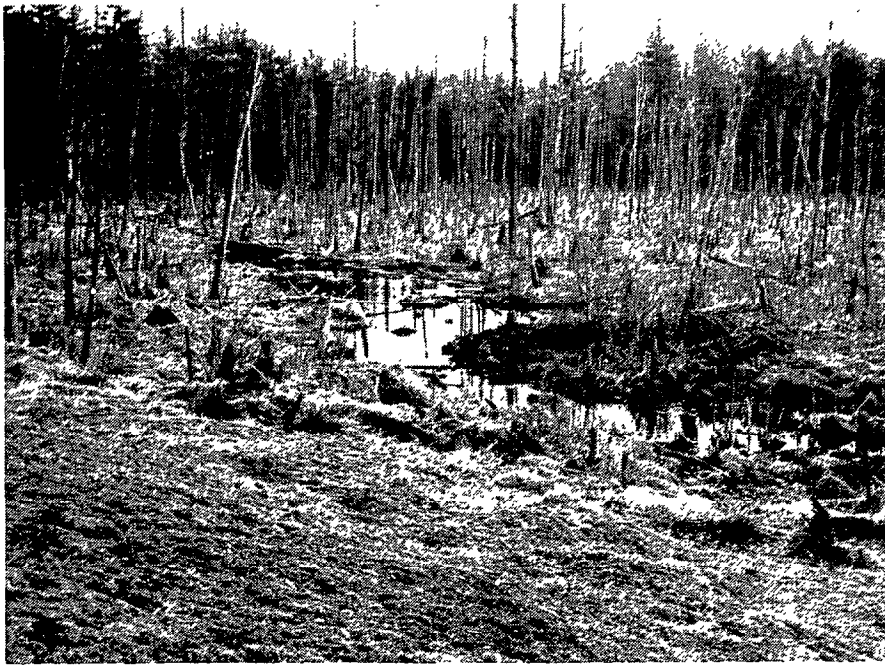
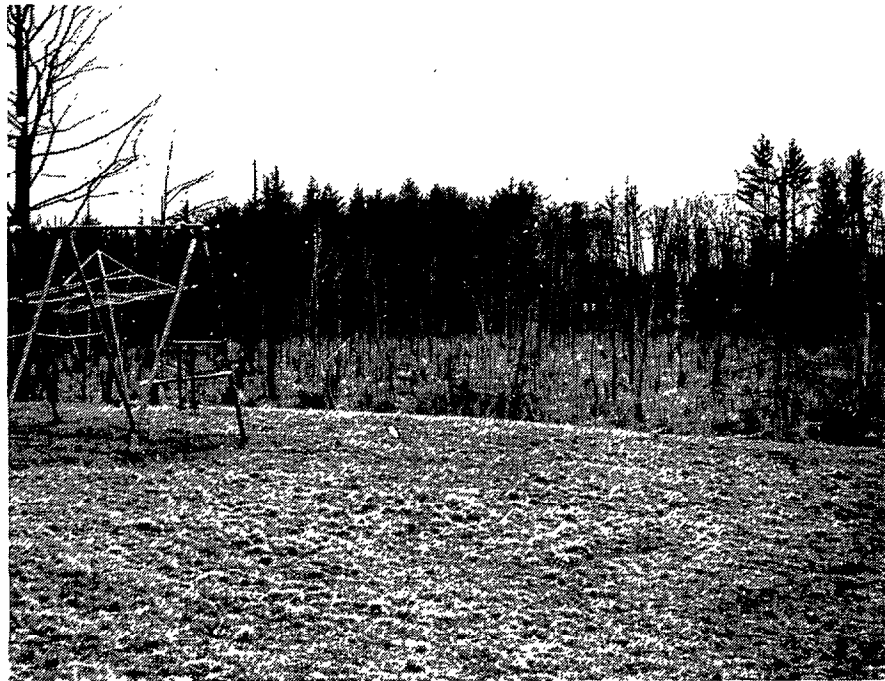
SWAMP BEHIND LOTS 509, 510, AND 511. THIS AREA ON SUBDIVISION PLAN IS DESIGNATED AS A PARK.

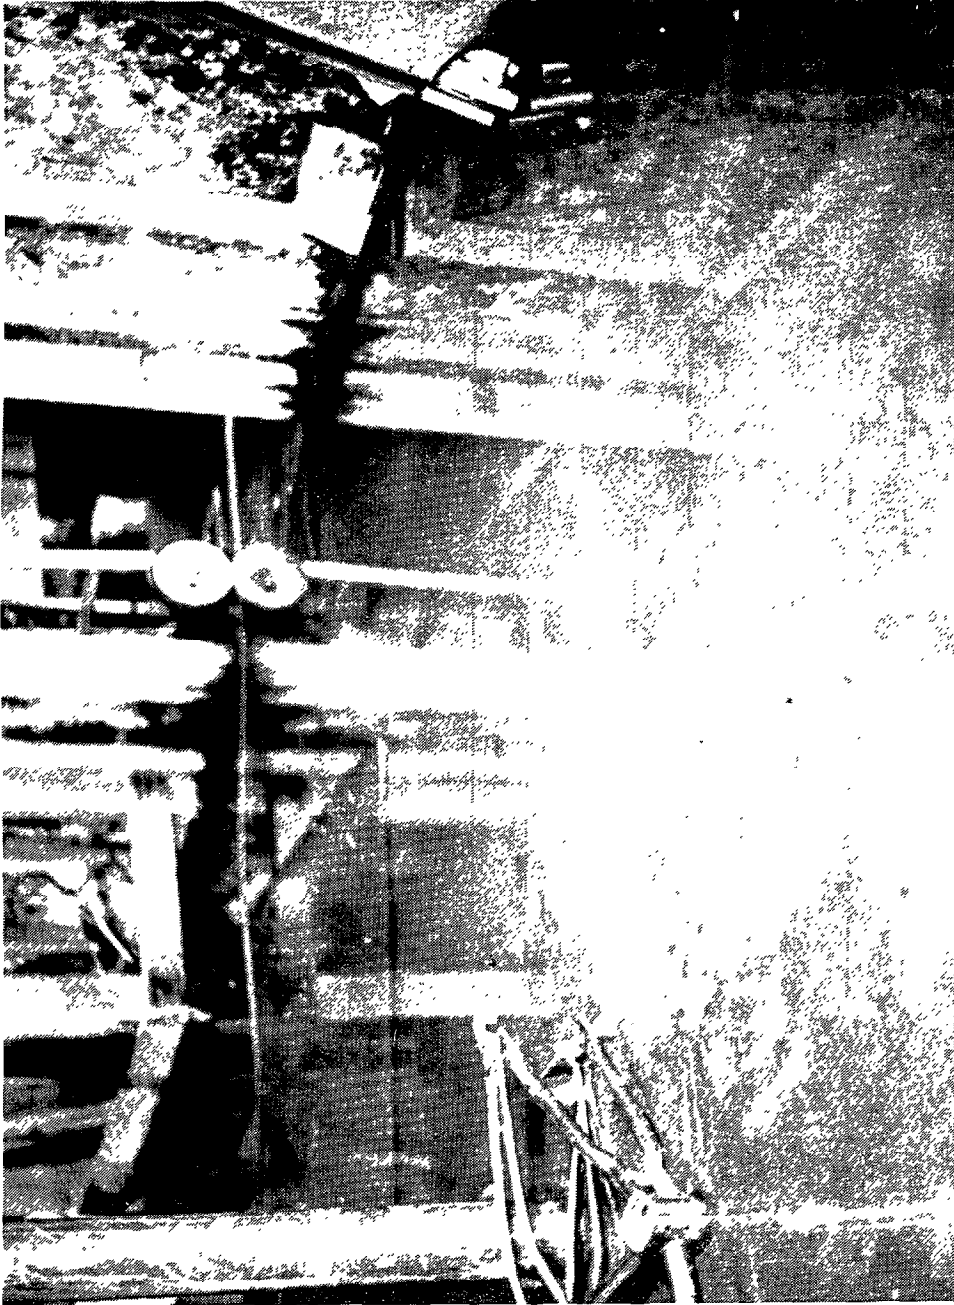
We visited the homeowner's basement in December 1975 and April 1976 after rainstorms. On the first visit, we observed 2 inches of water over a large area, including the area around the furnace. On the second visit, 2 days after a moderate rainfall, we observed a similar water condition as well as septic system waste which had backed up into the cellar through a washing-machine drain and which covered a large part of the laundry area. A photograph showing water leakage into the basement is on page 48.

HOMEOWNER'S BASEMENT WITH ABOUT 2 INCHES OF WATER AT THE TIME OF OUR APRIL 1976 VISIT. THE HOMEOWNER REPORTS THAT THIS OCCURS AFTER EVERY RAINSTORM.
