United States General Accounting Office

# NUCLEAR REGULATION

## Action Needed to Ensure That Utilities Monitor and Repair Pipe Damage

1/RCED-88-73

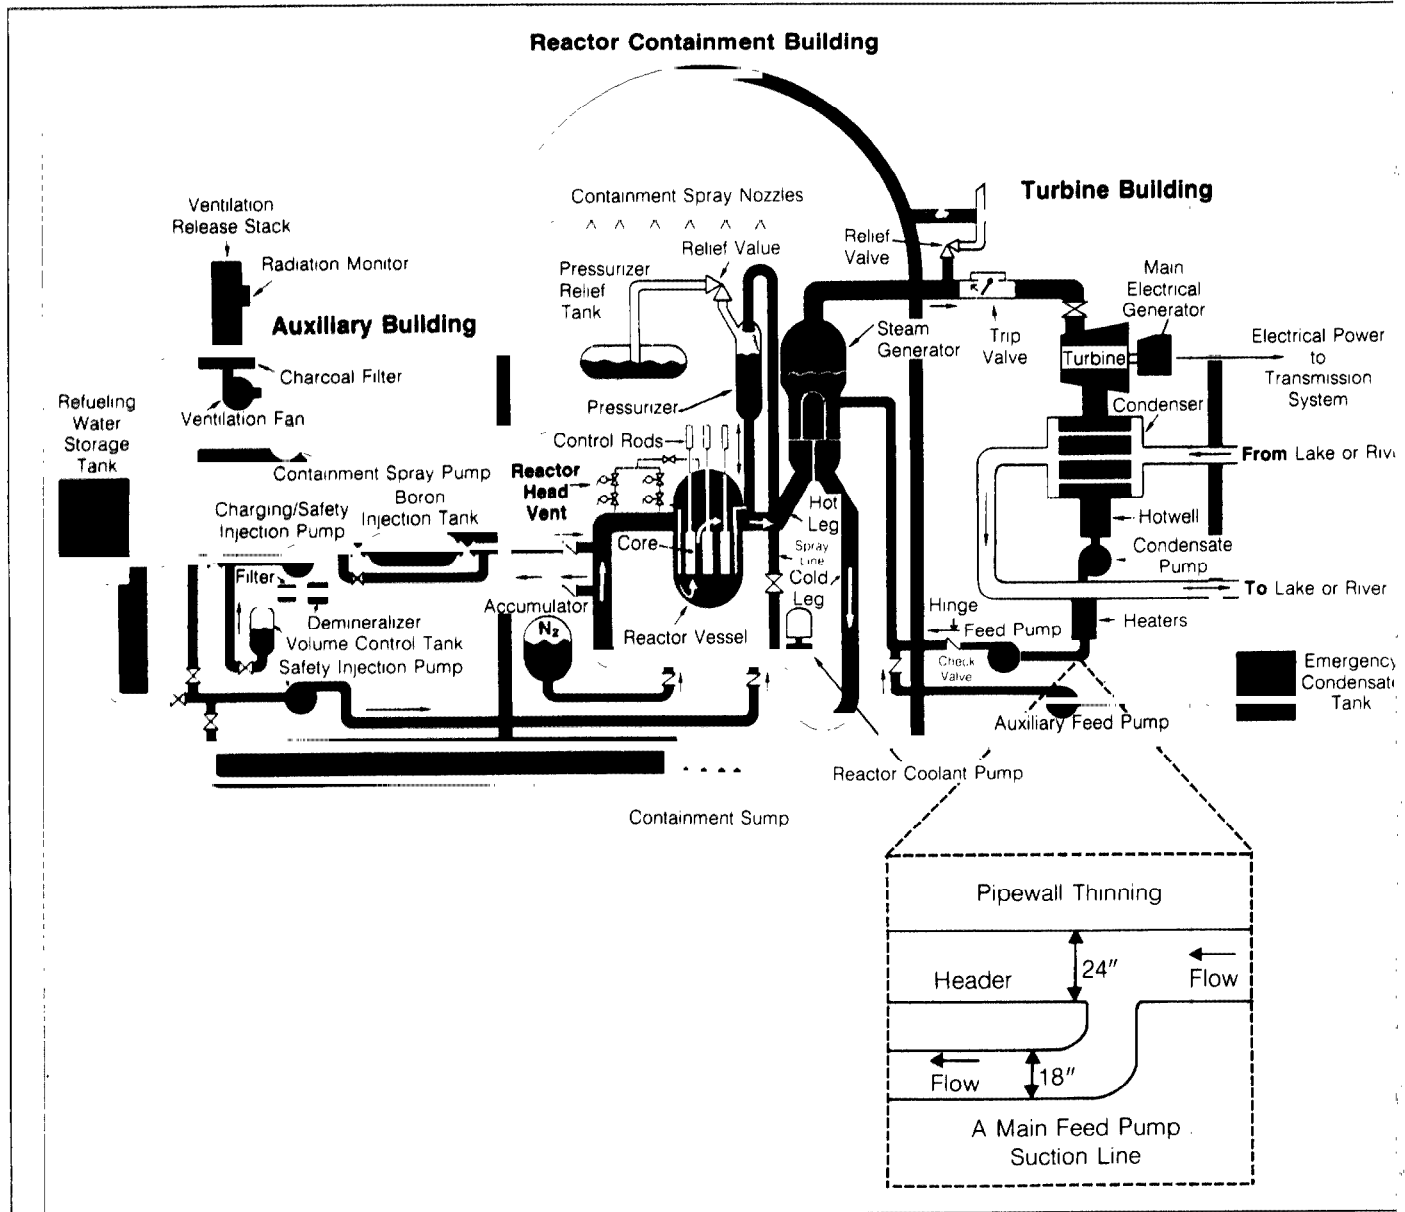
**Figure 2.1: The Piping System That Failed at Surry in Relation to the Rest of the Plant**

Figures 2.1, 2.2, and 2.3 provide a general approximation of the Surry nuclear plant and the pipe that failed. Figure 2.1 shows the location of the ruptured pipe in relation to the rest of the plant. Figure 2.2 illustrates the pipe before it failed, and figure 2.3 shows the pipe after it failed.

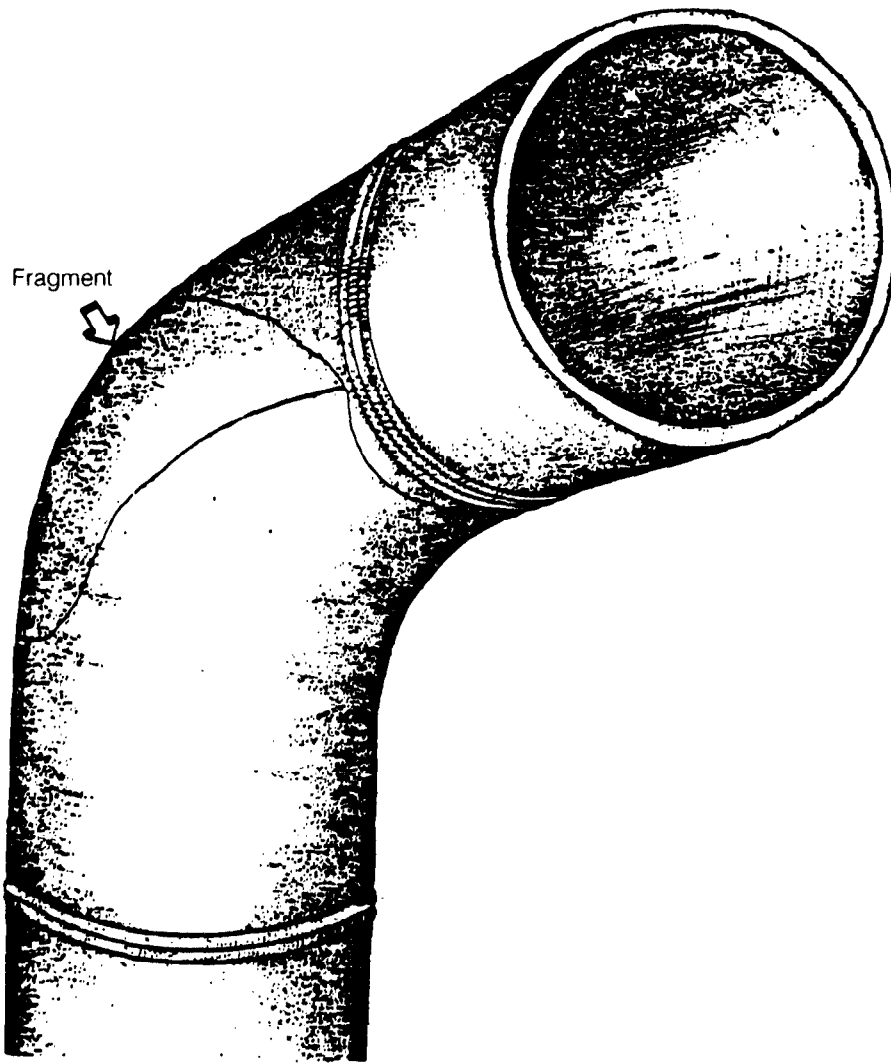
Figure 2.2: Drawing of the Pipe Before Rupture Indicating the Area of Failure

The pipe that failed was 18 inches in diameter and was welded to a 24-inch diameter pipe. The failure occurred approximately 1 foot from this joint, in an area where the pipe had been bent in a 90 degree angle to form an elbow. According to Virginia Power officials, the wall of the 18-inch diameter pipe should have been one-half inch thick. Upon examination, some areas were found to have eroded to the thickness of a credit card.

Virginia Power made only a few design modifications to the pipe systems at Surry. At both units, the pipe configuration in the area that failed was changed from a 90 degree angle to a less severe 45 degree angle. According to company officials, if large-scale changes had been made, the plants would have been out of service for 6 months to 1 year while they completed the required engineering analyses, design changes, and other modifications.

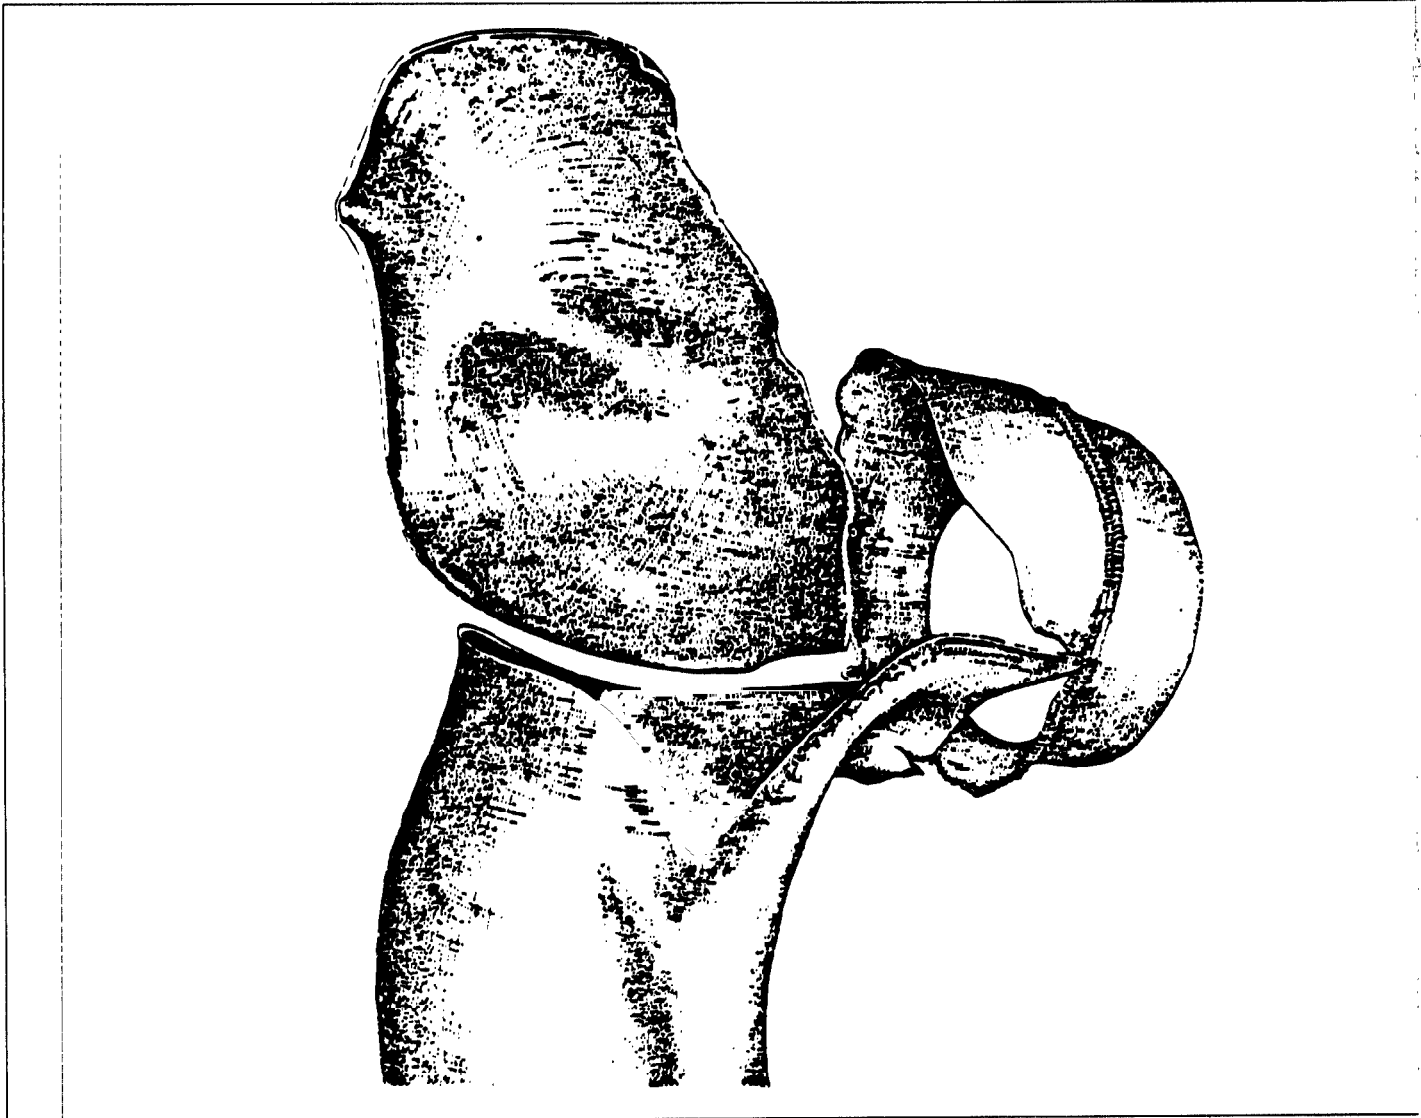
Figure 2.3: Diagram of the Failed Pipe Illustrating the 2 Foot by 3 Foot Section That Ripped Away

Prior to the accident, the portion of the feedwater line that failed was operating normally at 374 degrees Fahrenheit and 367 pounds of pressure. When the steam valve closed, several actions occurred quickly. Alarms indicating improper steam flow sounded in the control room, automatic safety protection systems shut down the reactor, and steam pressure in the steam lines increased rapidly. Approximately 35 seconds after the valve closed, the plant staff heard a small steam release; this sound was followed about 7 seconds later by a very loud noise. The noise was a pipe rupture in the feedwater system that recirculates water back to the equipment that produces steam. When the failure occurred, a section of pipe measuring approximately 2 feet by 3 feet blew out and landed on other equipment about 15 feet away. The force of the rupture moved the remaining pipe section approximately 6.5 feet.

Following the accident, Virginia Power formed a group of company officials to determine the cause of the accident and recommend corrective actions. The group concluded that the failure resulted from extreme thinning of the pipe caused by erosion/corrosion that occurred during the 14 years the plant had been in service.
