GAO

MILITARY FASTENERS

Changes to Specifications Are Justified

September 30, 1991

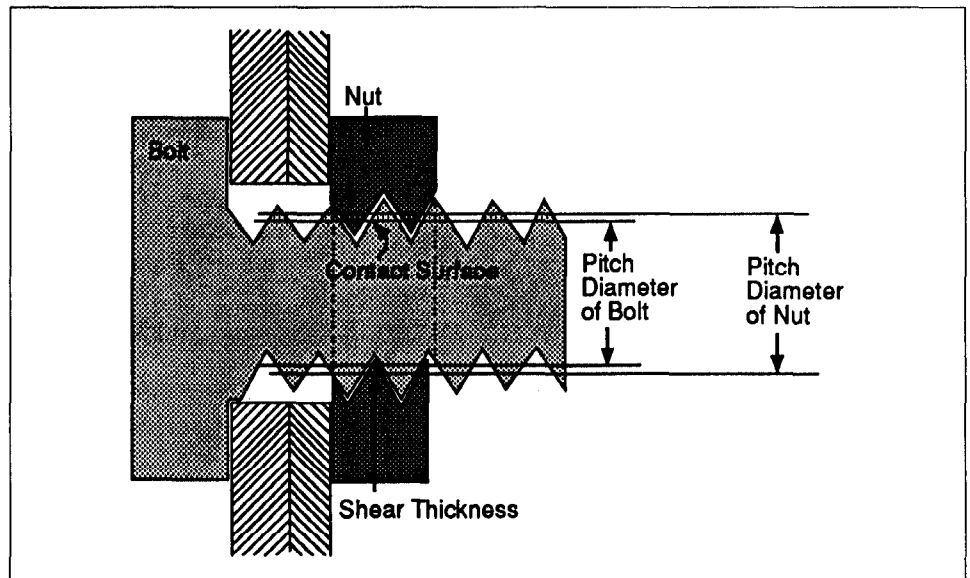
Figure I.1: Cross Section of a Threaded Assembly With a Correctly Sized Nut

Pitch diameter is a measure of size of the threads. It is defined as the diameter of the fastener where the thickness of the thread and the width of the groove between threads are equal. For a nut to assemble onto a bolt, the pitch diameter of the nut must be greater than the pitch diameter of the bolt. Figure I.1 shows a cross section of a threaded assembly using a nut with a correctly sized⁶ pitch diameter, and figure I.2 shows a cross section of a threaded assembly using a nut with an oversized pitch diameter. The oversized nut has less contact surface with the bolt and less shear thickness (the thickness across the width of the thread) than the correctly sized nut.

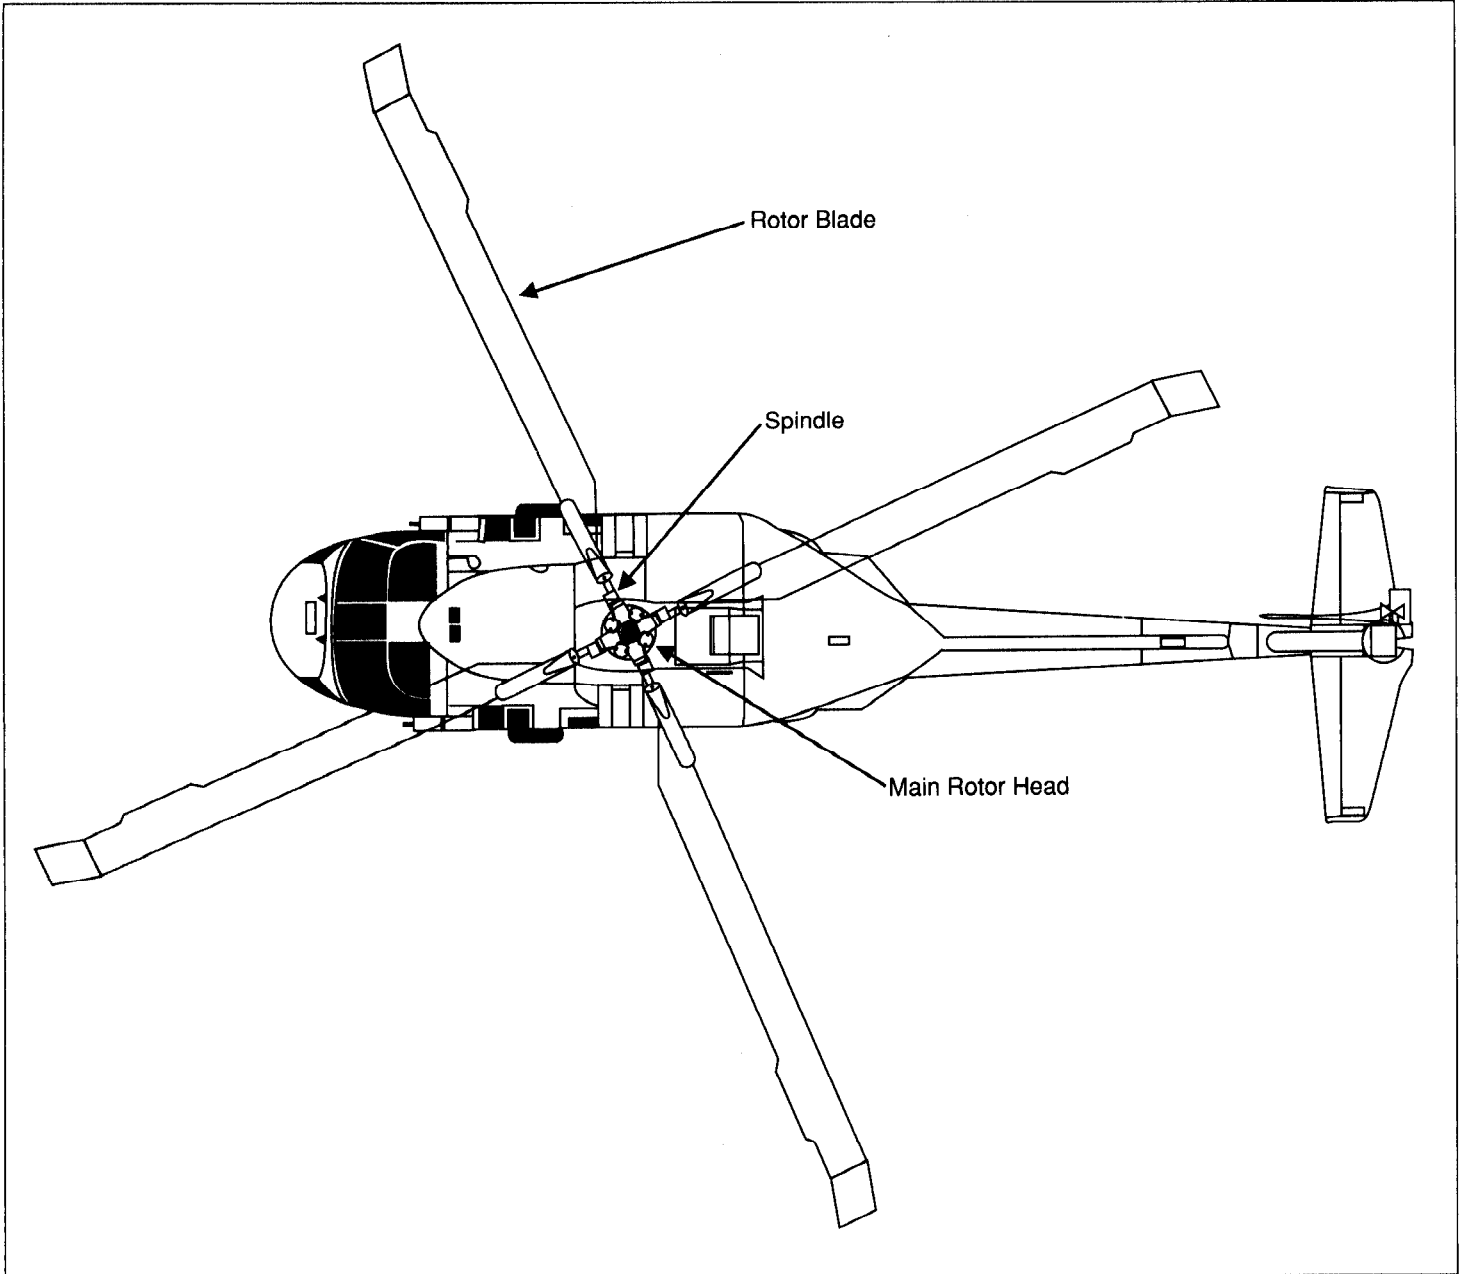
Figure II.2: Overhead View of UH-60A Helicopter

The UH-60A Blackhawk helicopter accident occurred on April 15, 1985. The Army Safety Center reported that the spindle (see fig. II.1) on one of the helicopter's main rotor blades failed. The spindle secures the rotor blade to the main rotor (see fig. II.2). The failure was due to a fatigue crack that originated near the root of the first complete thread (see fig. II.3). Spindles are normally replaced every 6,700 hours; however, this spindle failed after only 1,080 hours of use.
