# NUCLEAR SAFETY

## DOE's Investigation of Phosgene Gas Contamination Was Inadequate, but Experts Conclude That Worker Safety and Facilities Are Not Threatened

Highlights of [GAO-07-712](#), a report to congressional addressees

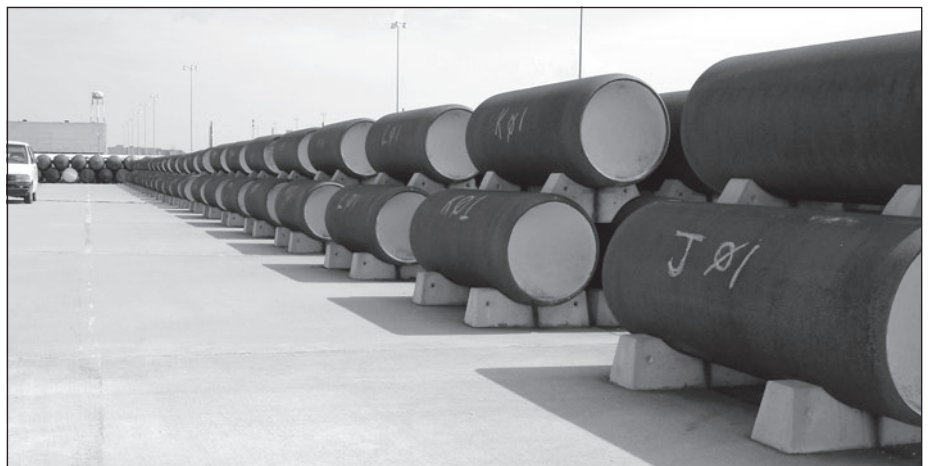
### Uranium Storage Cylinders at Paducah, Kentucky

The experts GAO consulted agreed that, for two reasons, the facilities under construction in Ohio and Kentucky would not be threatened by possible phosgene contamination of uranium storage cylinders. First, at the start of treatment operations, cylinders containing depleted uranium will be placed inside pressure vessels designed to withstand and contain any leak from a cylinder. If phosgene were present, it would not affect either the pressure vessels or the treatment facilities. Second, during subsequent steps, any phosgene that may be processed with the depleted uranium would be destroyed by the extreme heat and water vapor applied during the treatment process.

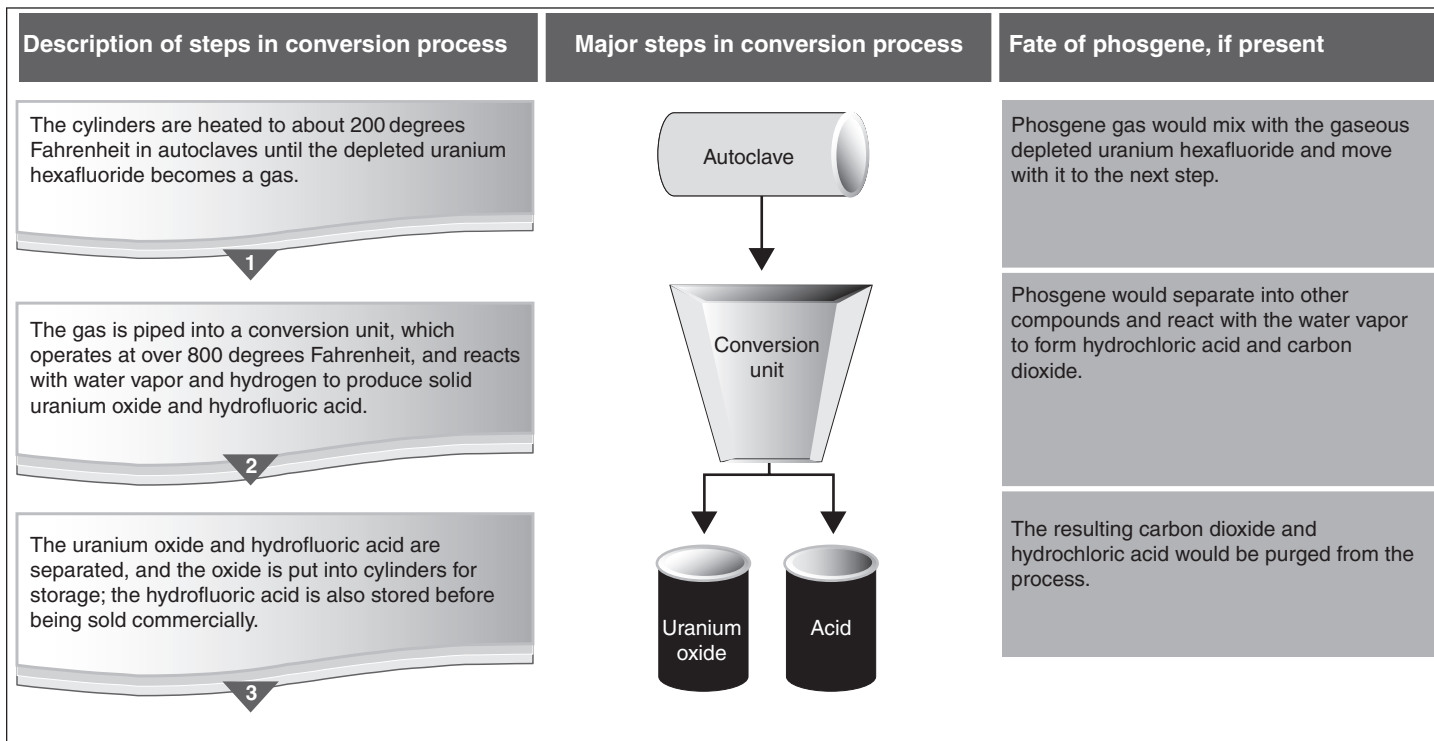
**Figure 3: Steps to Convert Depleted Uranium Hexafluoride to Uranium Oxide, with Impact on Phosgene, If Present**

The experts, as well as DOE and UDS officials, cited two main reasons for concluding that the conversion facilities would not be threatened if 1.2 grams or less of phosgene were present in the uranium storage cylinders. First, during the conversion process, the cylinders will be placed in pressure vessels (called autoclaves) that will heat their contents to approximately 200 degrees Fahrenheit. (Fig. 3 summarizes the conversion process and what would happen to any phosgene present.) According to UDS officials and experts we consulted, these autoclaves are designed to withstand any cylinder ruptures and to contain the contents of the cylinders, regardless of whether phosgene is present. Specifically, the autoclaves are designed to withstand pressures up to 200 pounds per square inch and temperatures exceeding 200 degrees Fahrenheit, and their interiors are treated with a protective coating that resists heat and corrosive chemicals. They would therefore withstand any depleted uranium hexafluoride or phosgene that might leak from a ruptured cylinder into the interior of the autoclave. Furthermore, if a cylinder did rupture, according to UDS officials, sensors in the autoclave would detect any depleted uranium hexafluoride released. These sensors would alert workers, who could then shut down the autoclave and follow safety procedures for cleaning it out.

carbon monoxide and chlorine gases below 800 degrees Fahrenheit, any phosgene would separate and react with the water vapor, forming carbon dioxide and hydrochloric acid, neither of which would threaten the conversion equipment. According to UDS officials, the carbon dioxide would be vented from the conversion system with other gases through exhaust stacks. The hydrochloric acid would also react with the water vapor and be purged from the system. Thus, any residual amounts of phosgene that may be introduced into the depleted uranium conversion process would be destroyed and would not threaten any part of the conversion facilities.
