United States General Accounting Office

# NUCLEAR REGULATION

## Action Needed to Ensure That Utilities Monitor and Repair Pipe Damage

1/RCED-88-73

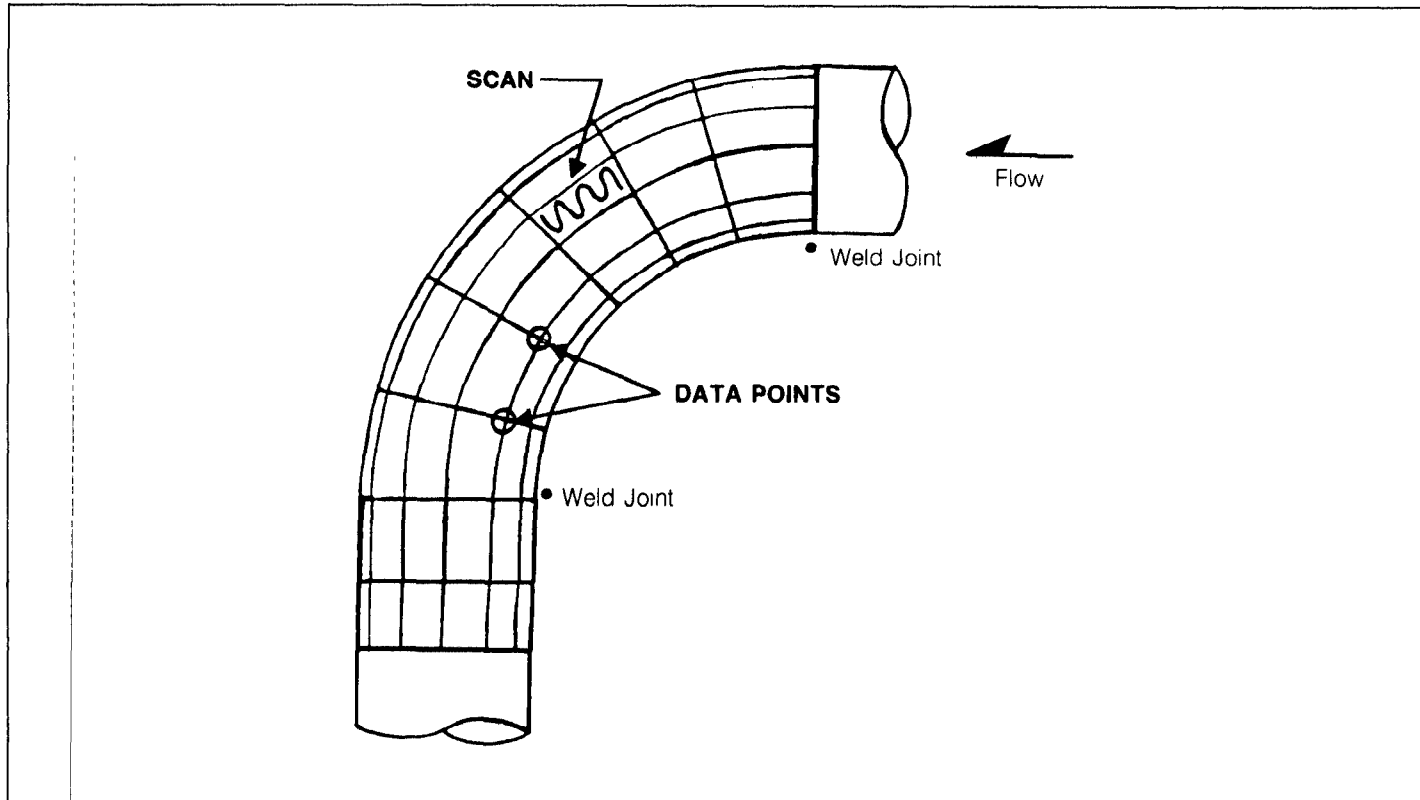
Figure 2.4: Typical Ultrasonic Test Grid Pattern

Utilities cannot detect erosion/corrosion by visual observation because it progresses outward from the interior of a pipe. According to NRC staff, utilities can use two methods to determine the thickness of pipe: ultrasonic tests or radiography. Ultrasonic tests are performed by placing an instrument directly on the pipe and pulsing a sound wave through it. The sound wave is reflected back and converted into a thickness measurement. Radiography uses X-rays to measure pipe. The thermal insulation surrounding pipes must be removed before ultrasonic tests can be performed but can be left in place for radiography. Figure 2.4 illustrates a typical grid pattern that is used to perform ultrasonic tests.
