# STRATEGIC BOMBERS

## B-1B Parts Problems Continue to Impede Operations

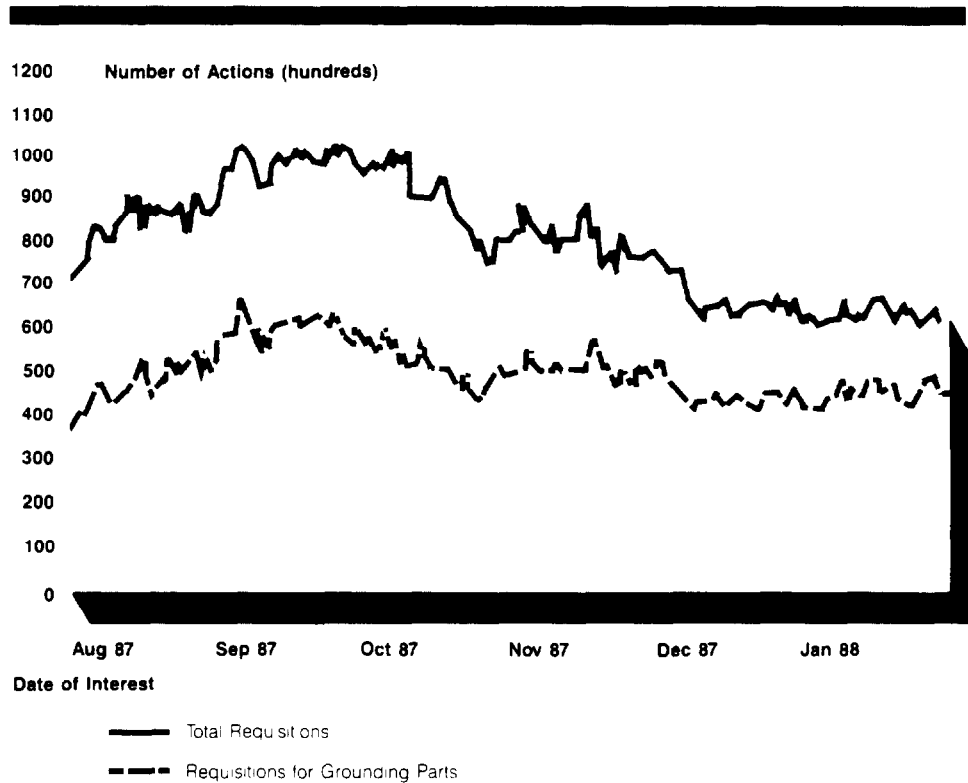
The daily average of high-priority requisitions for parts, those parts that affect mission capability, increased from about 200 in March 1987 to about 600 in January 1988, after reaching a high of about 1,000 in September 1987. During this period the number of delivered aircraft increased from 40 to 83. As shown by figure II.1, data from the Air Force's high-priority requisitions system showed that for about 60 percent of the requisitions, the missing part was one that would ground the aircraft.

**Figure II.1: High-Priority and Grounding Requisitions**

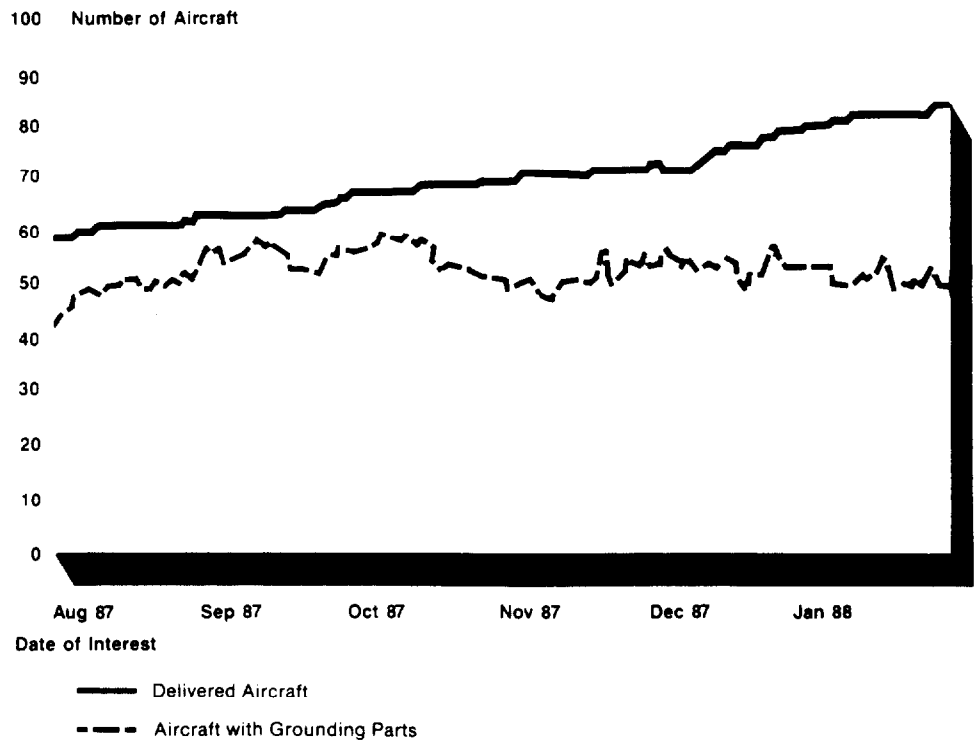
Figure II.2 shows, on a daily basis, the number of delivered aircraft that had grounding parts on order from August 1, 1987, through January 31, 1988. In general, about 50 aircraft had grounding parts on order. This means that each of the 50 aircraft was not ready for flight for at least some portion of the day or, as a minimum, was not capable of performing some missions.

Figure II.2: Aircraft With Grounding Parts On Order
