January 1991

BATTLESHIPS

Issues Arising From the Explosion Aboard the U.S.S. Iowa

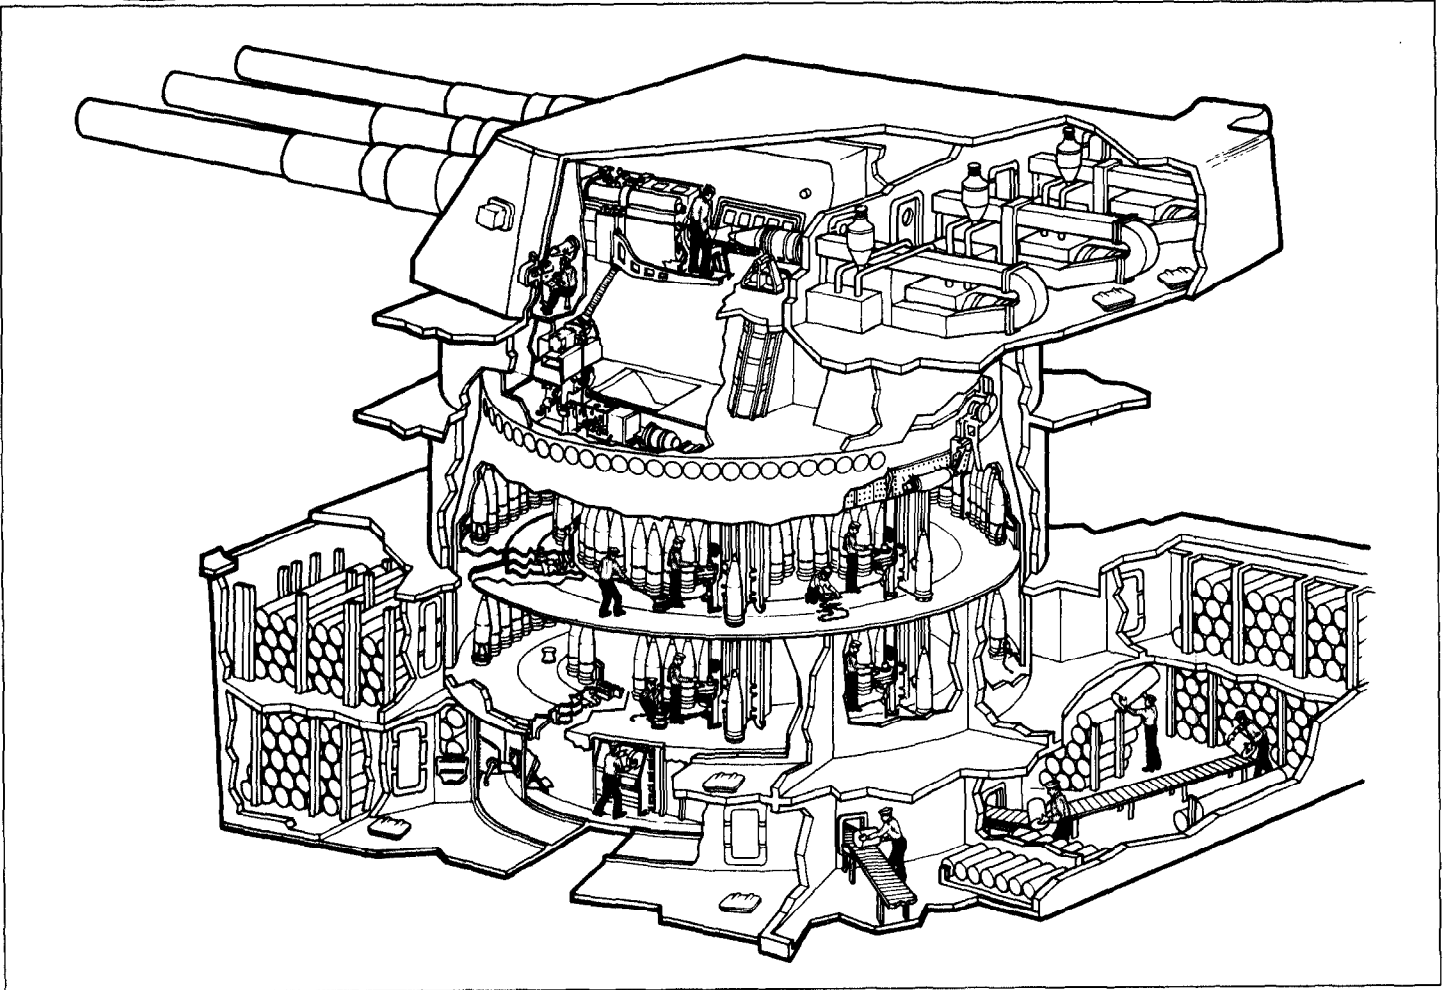
Figure 1.2: Iowa Class Battleship 16-Inch Gun Turret

The ships' principal armament, as built, was a main battery of nine 16-inch guns. Three guns are mounted, as illustrated in figure 1.2, in each of the three turrets. The guns, using several types of powder, fire a variety of projectiles that weigh up to 2,700 pounds and that have ranges in excess of 23 miles. The ships also originally carried 20 5-inch guns, which have a range of about 10 miles, in 10 gun mounts, two guns each. However, upon reactivation, four of these mounts were removed from each ship.

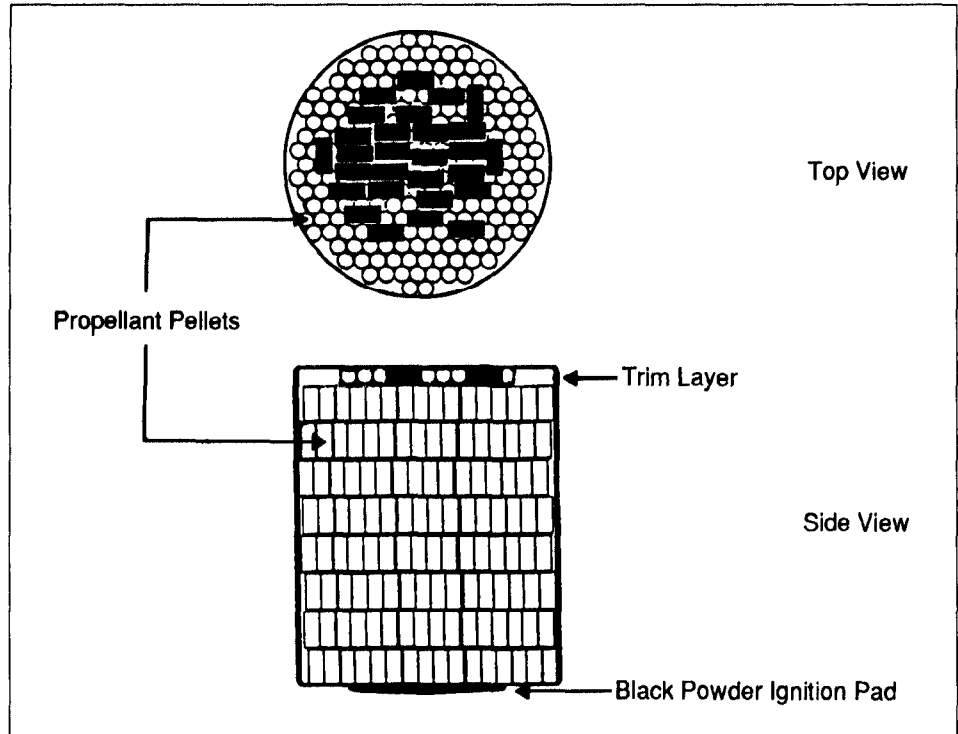
Figure 1.3: Powder Configuration of the Type of Powder Involved in the low Explosion

The powder for the 16-inch guns is contained in silk bags. Six bags are the standard charge to fire a projectile. Each bag of the type of powder involved in the Iowa explosion contained about 94 pounds of propellant pellets. As shown in figure 1.3, these pellets are stacked vertically in the bag in eight layers. Each bag also contains a trim layer that consists of a variable number of propellant pellets placed horizontally on the top layer of vertically stacked pellets when necessary to standardize the weight of the charge. Additionally, a pad containing black powder is sewn to the base of the bag.

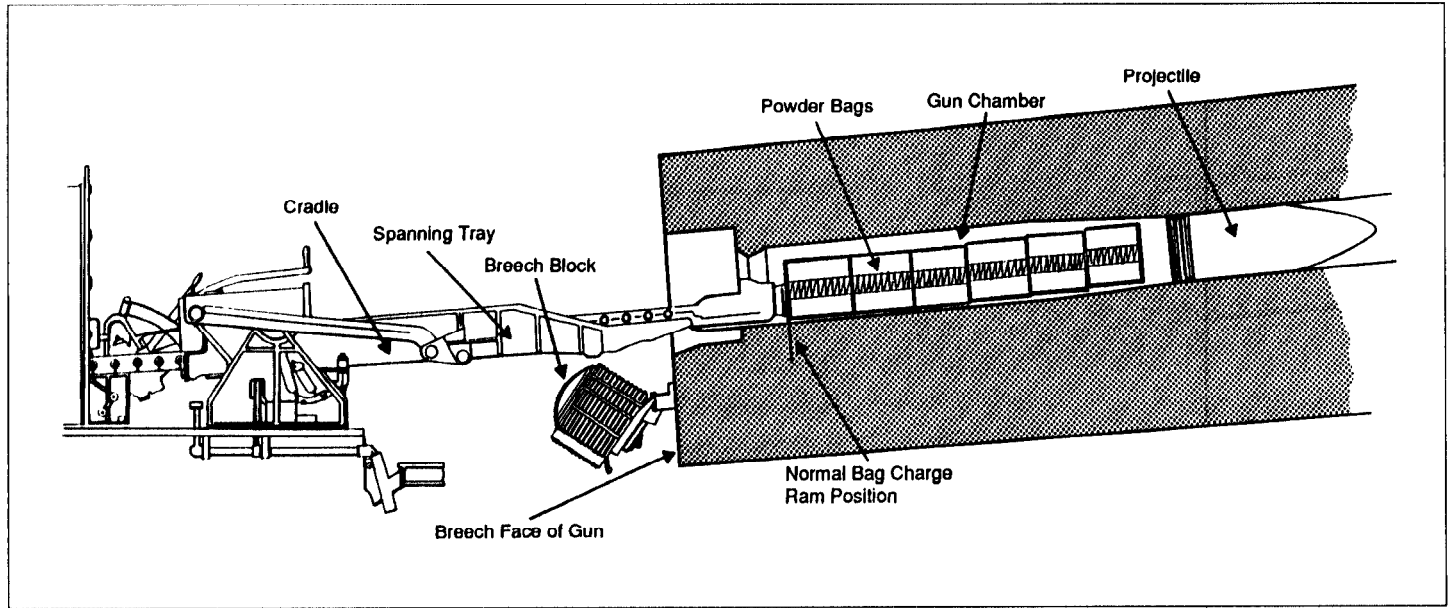
Figure 1.4: Gun and Rammer

Both the projectiles and the powder are loaded into the 16-inch guns using an electric-hydraulic rammer mechanism (see fig. 1.4). The projectile is loaded first, after which the powder bags are loaded. A crew member, responding to hand signals from the gun captain, controls the speed and length of the ram with a manually operated lever. Projectiles are to be rammed at a speed of about 14 feet a second, while the powder charge is to be rammed at about 1 to 2 feet a second. When a gun is fired, the black powder of the bag closest to the breech block is ignited by the primer, which ignites the propellant.

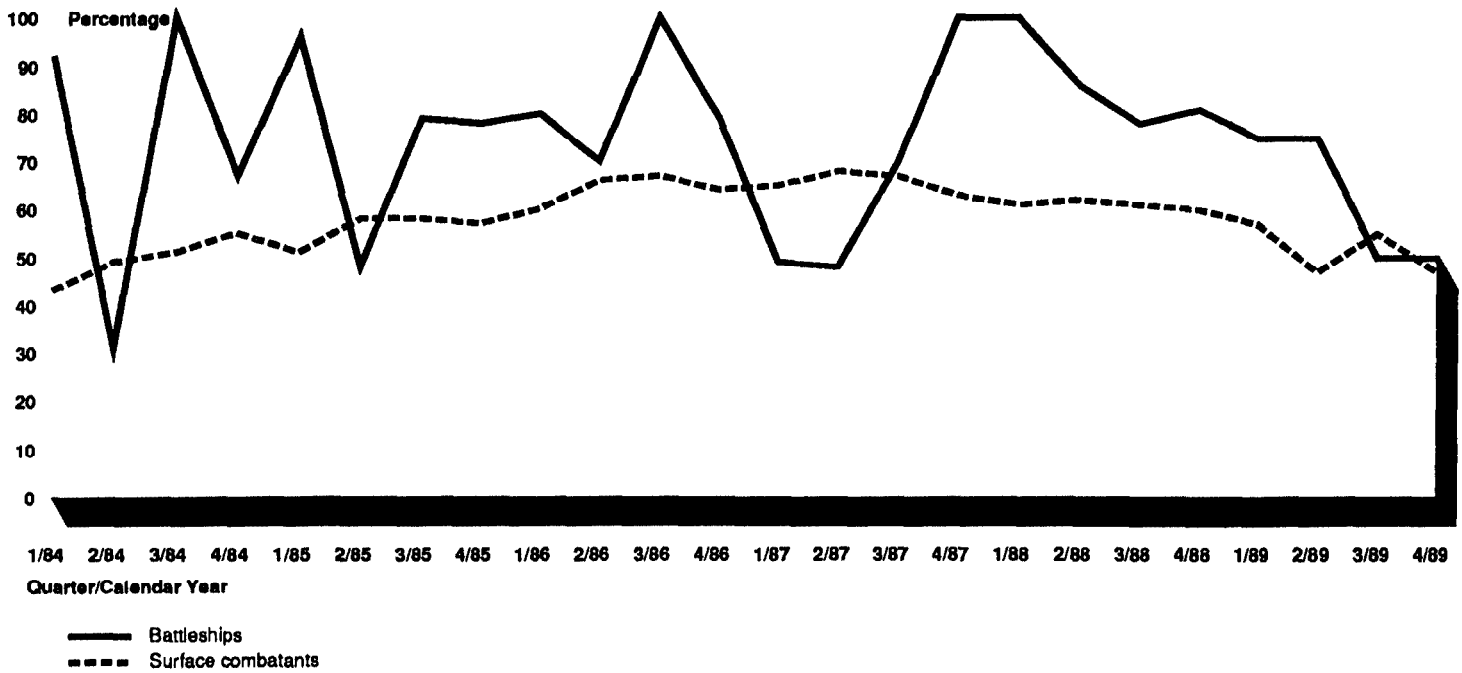
Figure 3.1: Operating Time Free of Serious Equipment Failures

For a broader comparison, we compared the battleships' overall equipment readiness to that of other Navy surface combatants to determine if the battleships, as a group of ships, present any undue material or supply support problems. As figure 3.1 shows, between 1984 and 1989 the battleships operated without any failures that had a major impact on or precluded the ships from performing a primary mission for a substantially greater percentage of time than did surface combatants as a whole. The battleships had the better record in this regard for 19 of the 24 quarters in this period. Additionally, the battleships reported no failures of this severity during four quarters. During the period covered by the comparison, the number of battleships in commission increased from one to four while the total number of surface combatants ranged from about 180 to about 200. The battleships' experience showed more variation than did the surface combatants because of the small number of battleships in commission.

There were no distinct overall differences between the battleships and the surface ships in the proportion of the total number of equipment failures due to the unavailability of repair parts, about 62 percent of the total failures in each case. However, only about 3 percent of the battleships' total supply-related failures had a major impact on or precluded the ships from performing a primary mission while about 11 percent of the supply-related failures for all surface ships were so categorized.
